WEST OXFORDSHIRE
DISTRICT COUNCIL

Parish Flood Report: **Eynsham**

July 2008

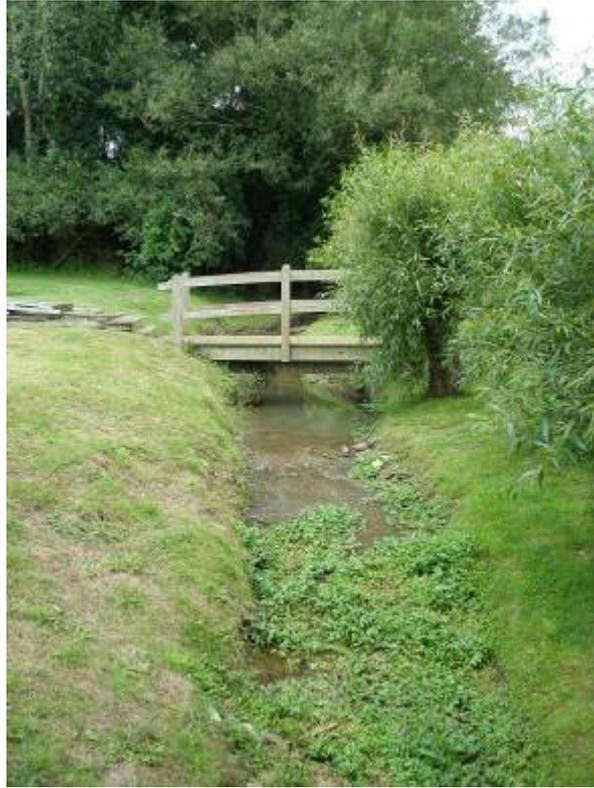
A number of driveway access points have been built across the Chil Brook at Barnard Gate (see photo 1 for example). This restricts flow along the watercourse and causes water levels to rise upstream of the bridge crossings, flowing out of bank onto surrounding land leading to flooding of property.

Photo 1 – Bridge Obstructions at the top of Barnard Gate.

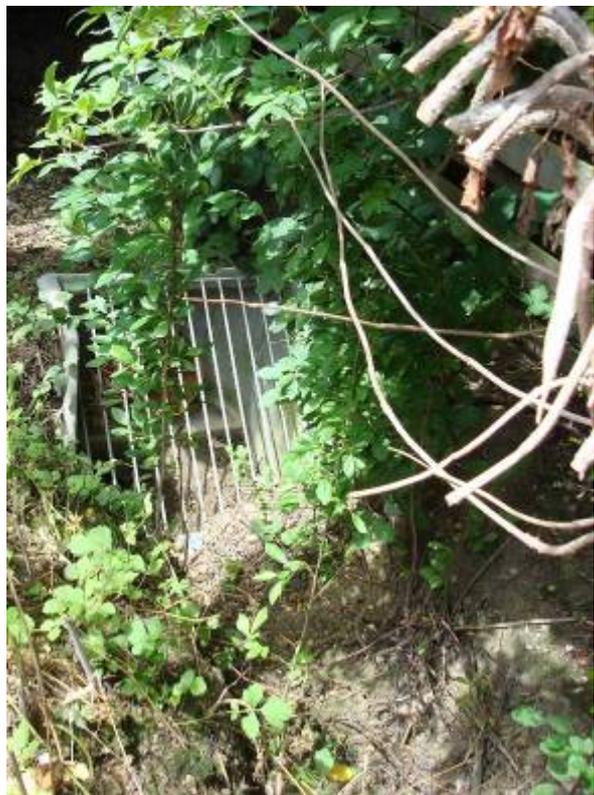
Photo 2 – Field drainage entering a pipe at the rear of properties on Barnard Gate

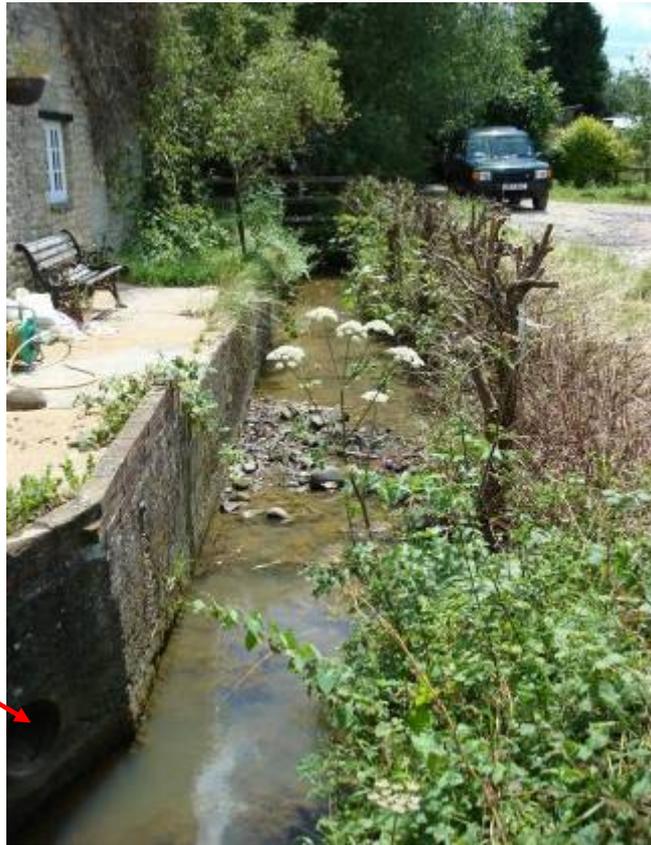
Photo 3 – Exist of field drainage at the front of property on Chil Brook

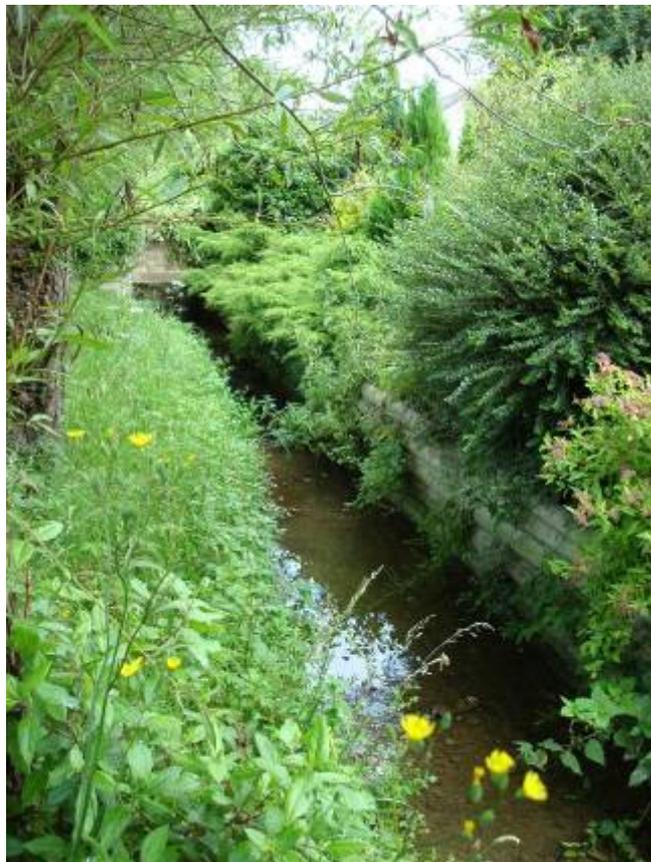
Photo 4 – Chil Brook flowing in front of property at Barnard Gate

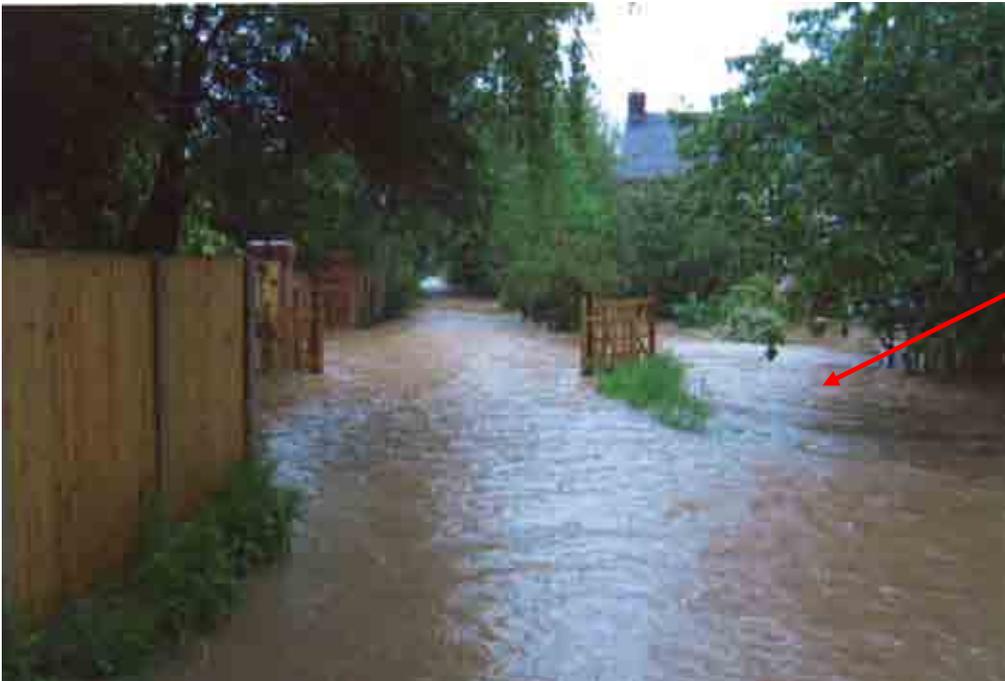
Photo 5 – Chil Brook in flood **3rd June 2008**. Photo is looking upstream at Barnard Gate with the old A40 behind

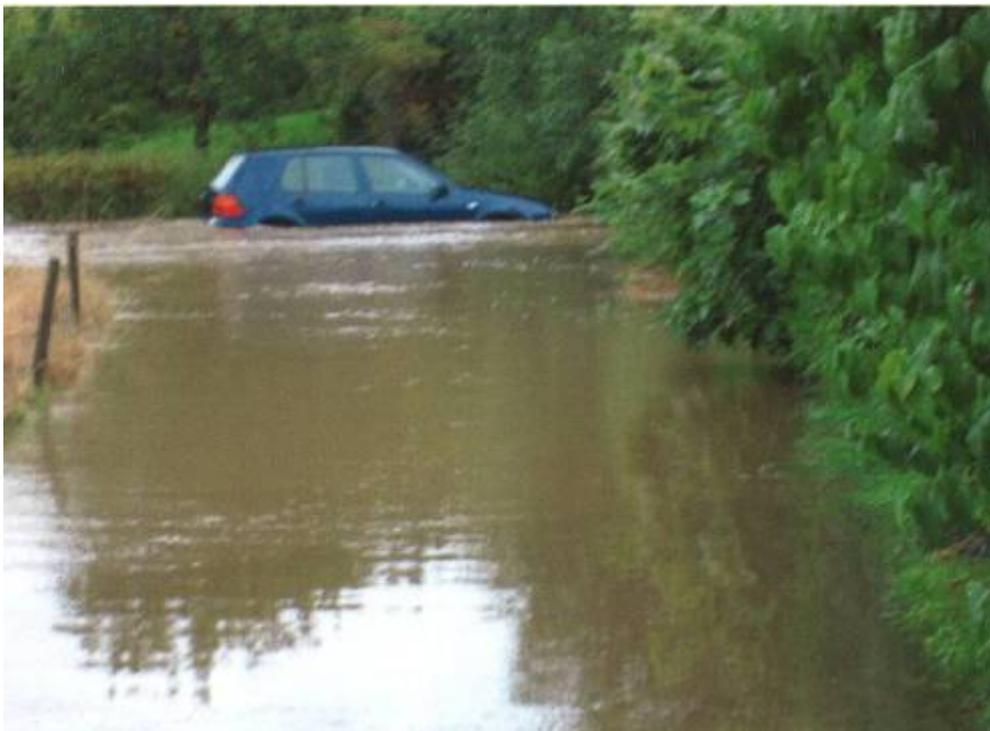
Photo 6 – Barnard Gate in flood **20th July 2007**

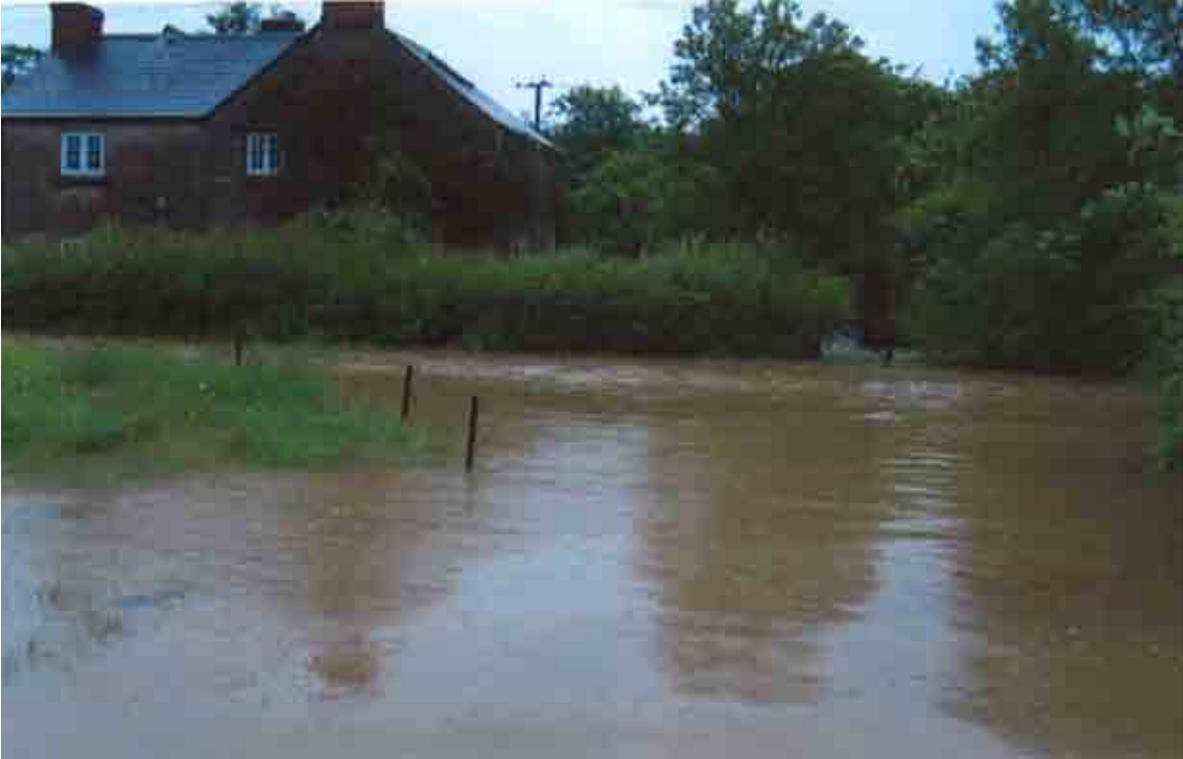
Photo 7 – Barnard Gate in flood 3rd June 2008

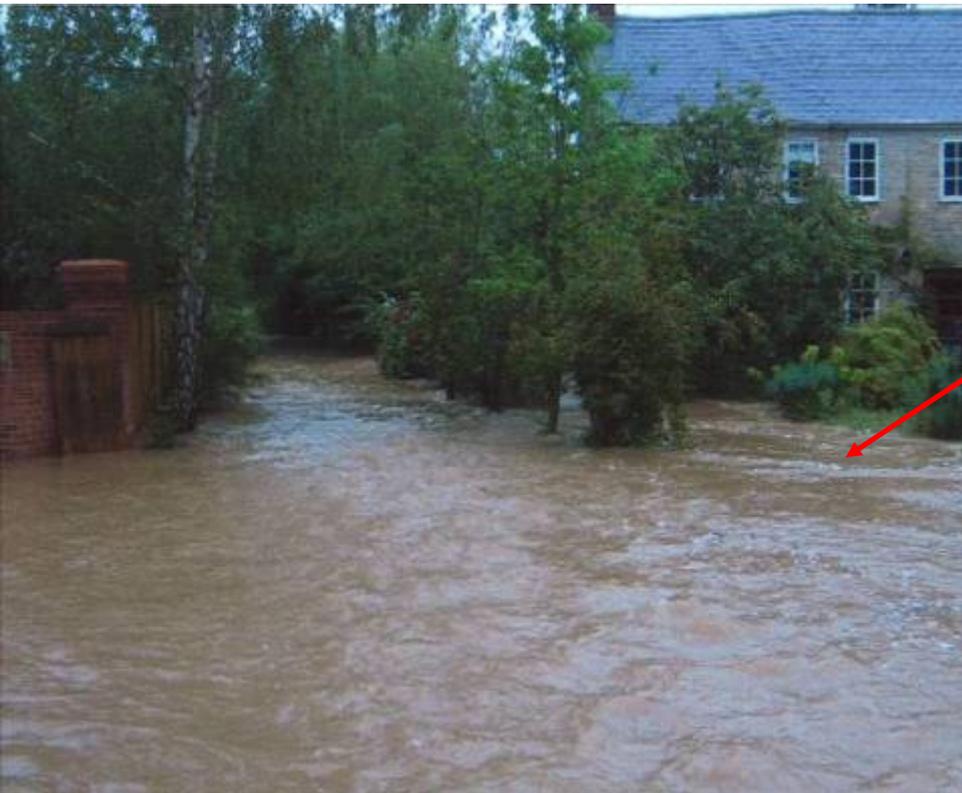
Photo 8 – Barnard Gate in flood 3rd June 2008

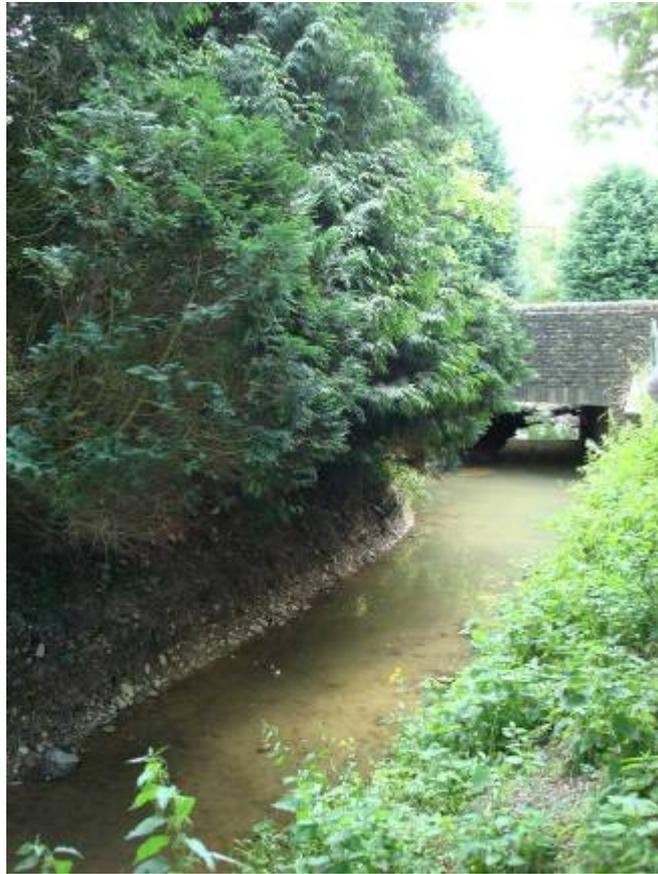
Photo 9 – Old A40 road bridge looking downstream to bridge

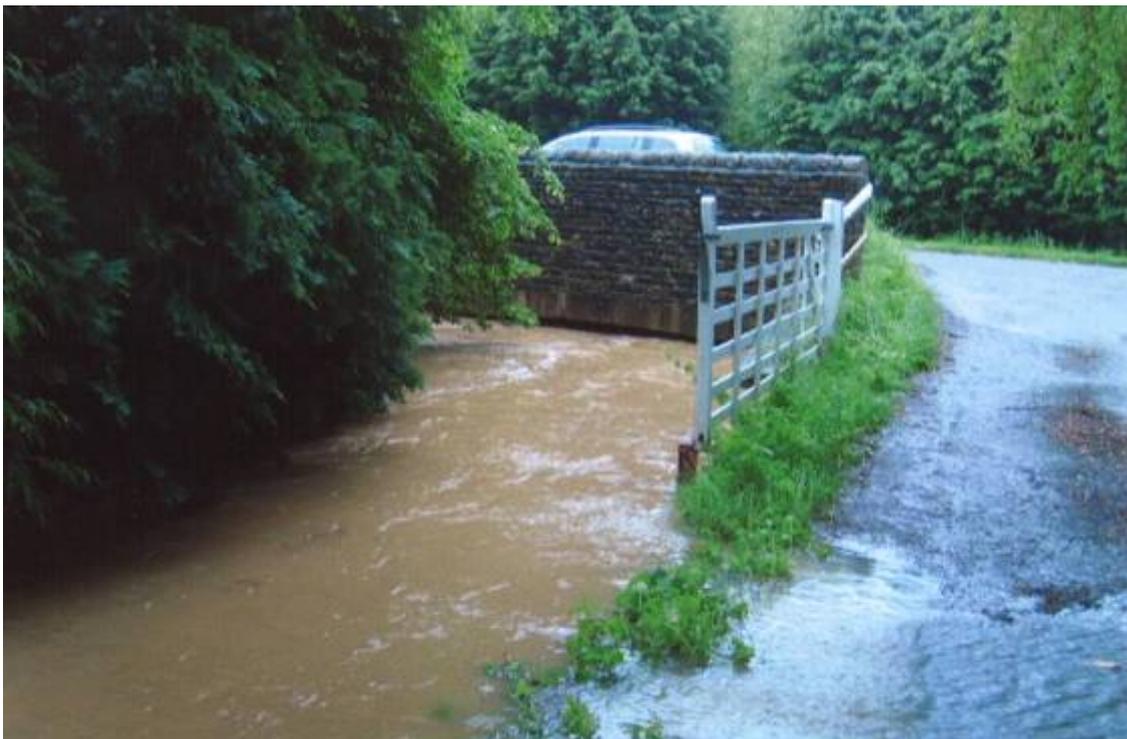
Photo 10 – Old A40 road bridge **3rd June 2008**. Note the flood level of this event was lower than that of June 2007.

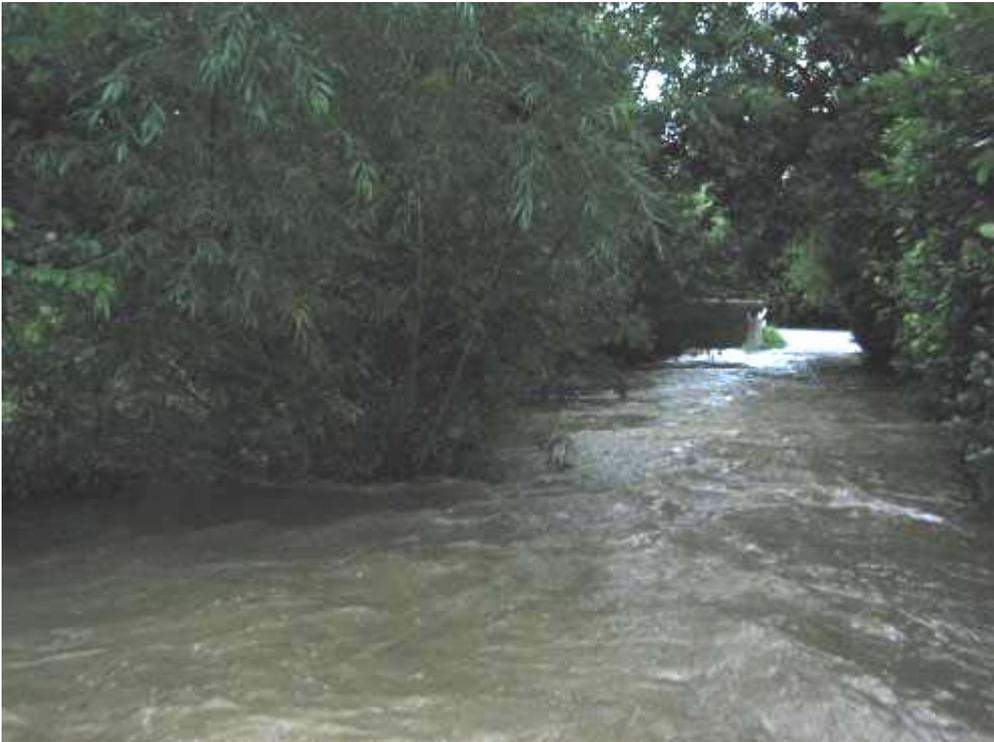
Photo 11 – Old A40 road bridge **June 2007** – water is over the lane and bridge is surcharged.

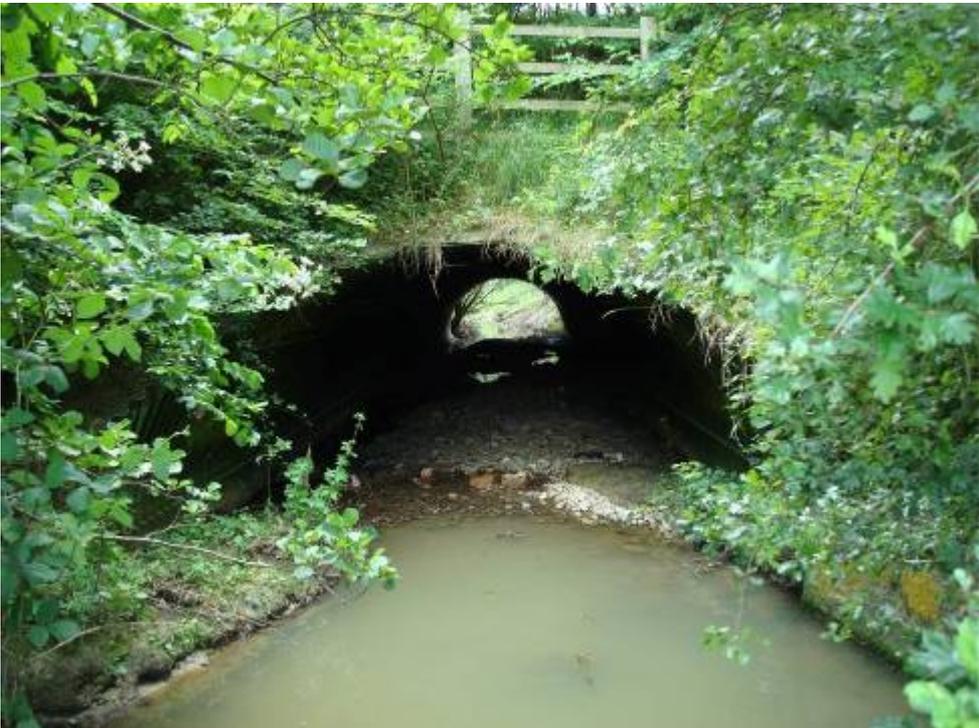
Photo 12 – New A40 crossing requiring maintenance of the channel bed (Chil Brook).

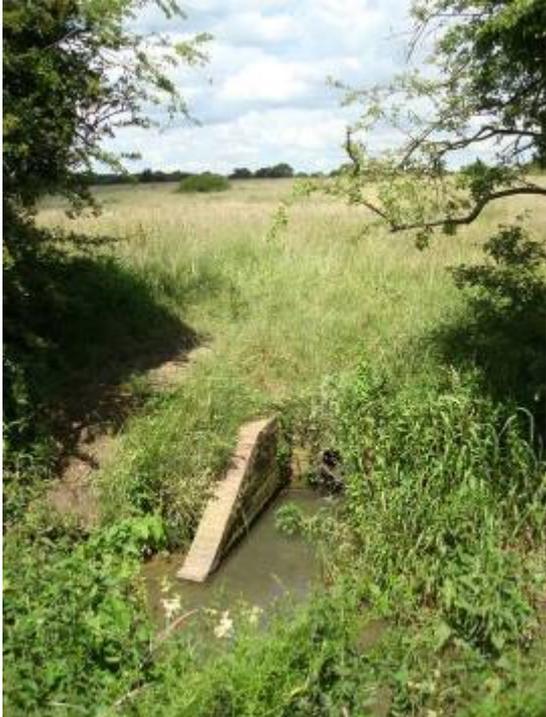
Photo 13 – Field drainage outfalling to the Chil Brook just upstream of Chil Bridge

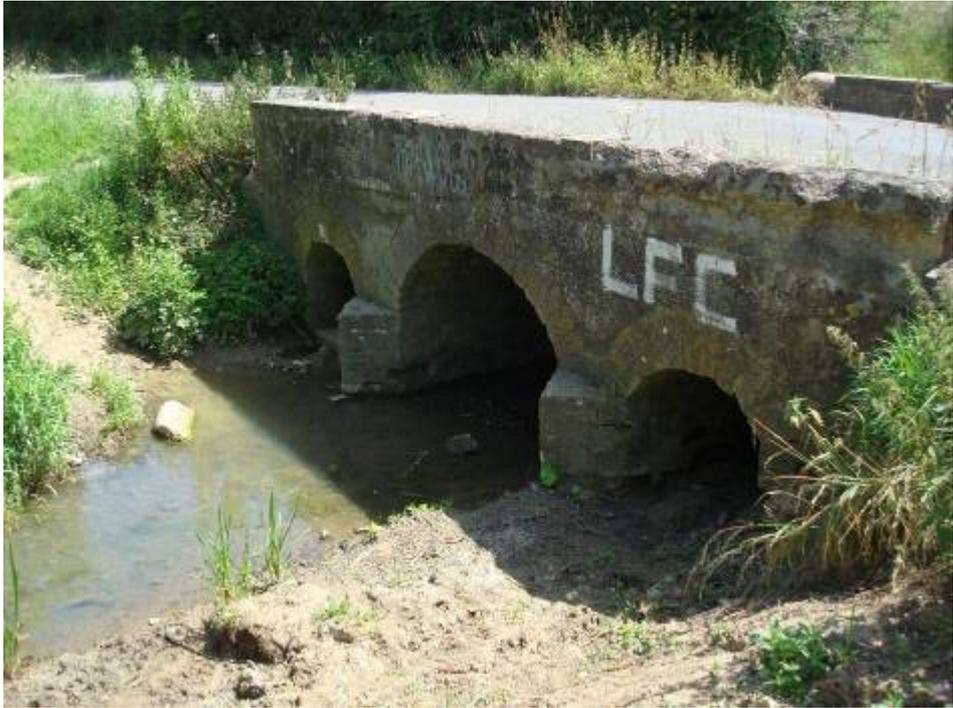
Photo 14 – Upstream face of Chil Bridge

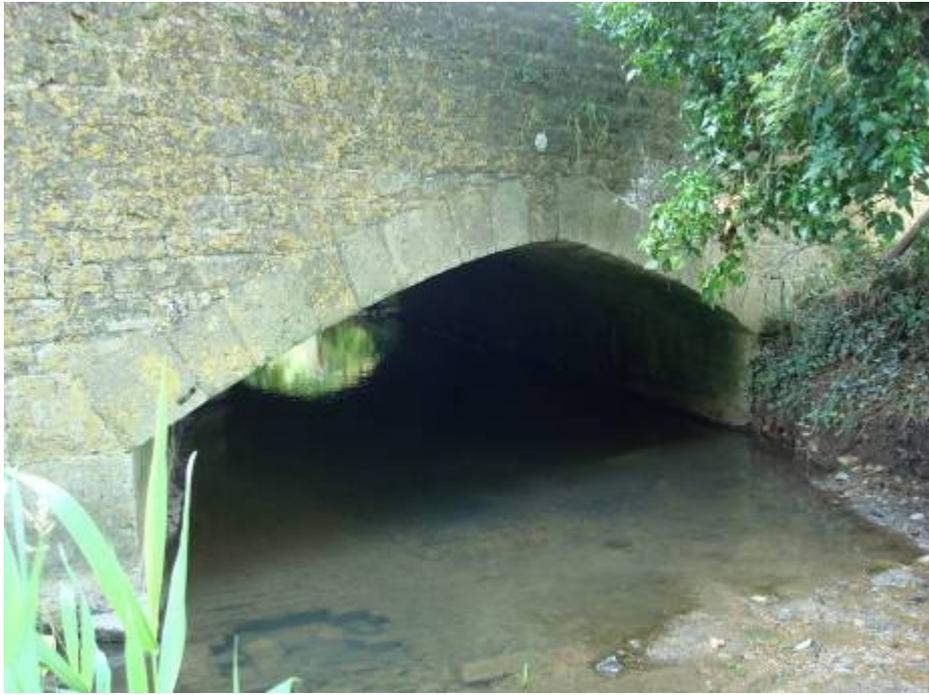
Photo 15 – Station Road/Chilmore Bridge looking downstream

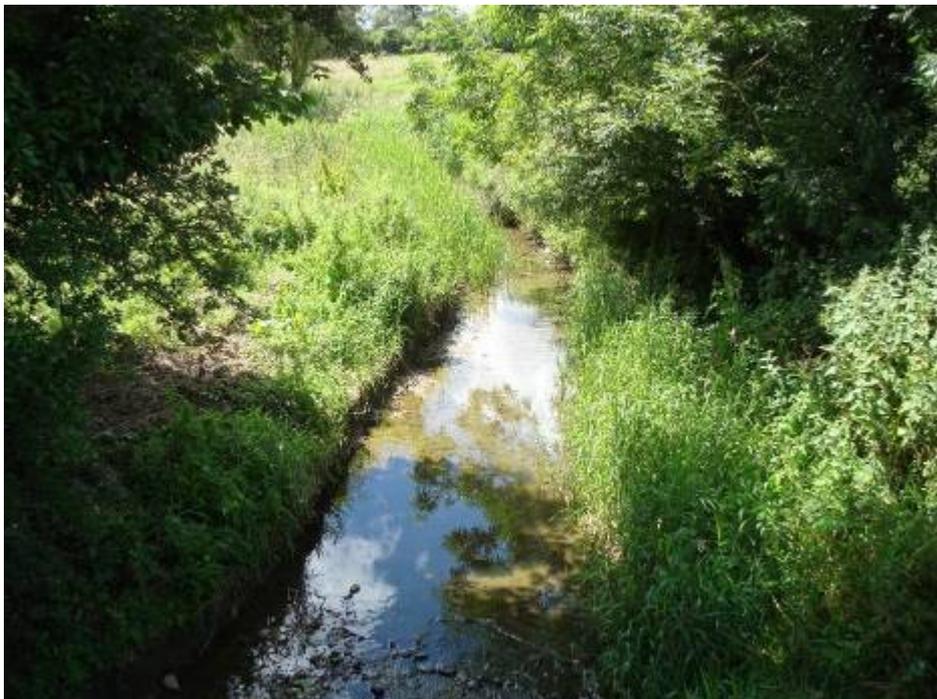
Photo 16 – Chil Brook at Station Road Bridge looking upstream from the bridge

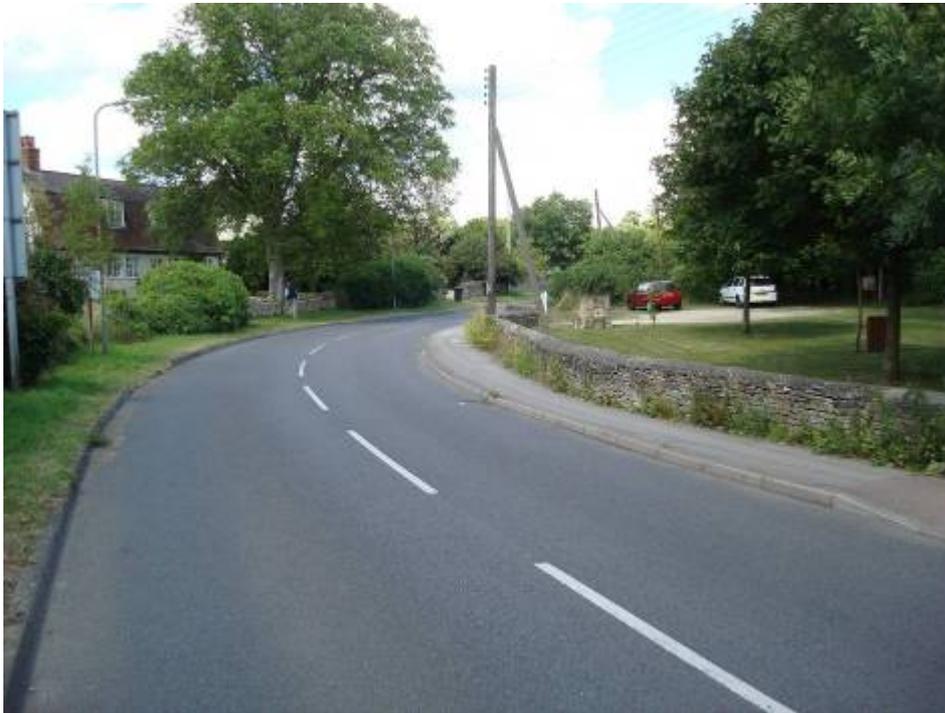
Photo 17 – Looking along Station Road towards Eynsham

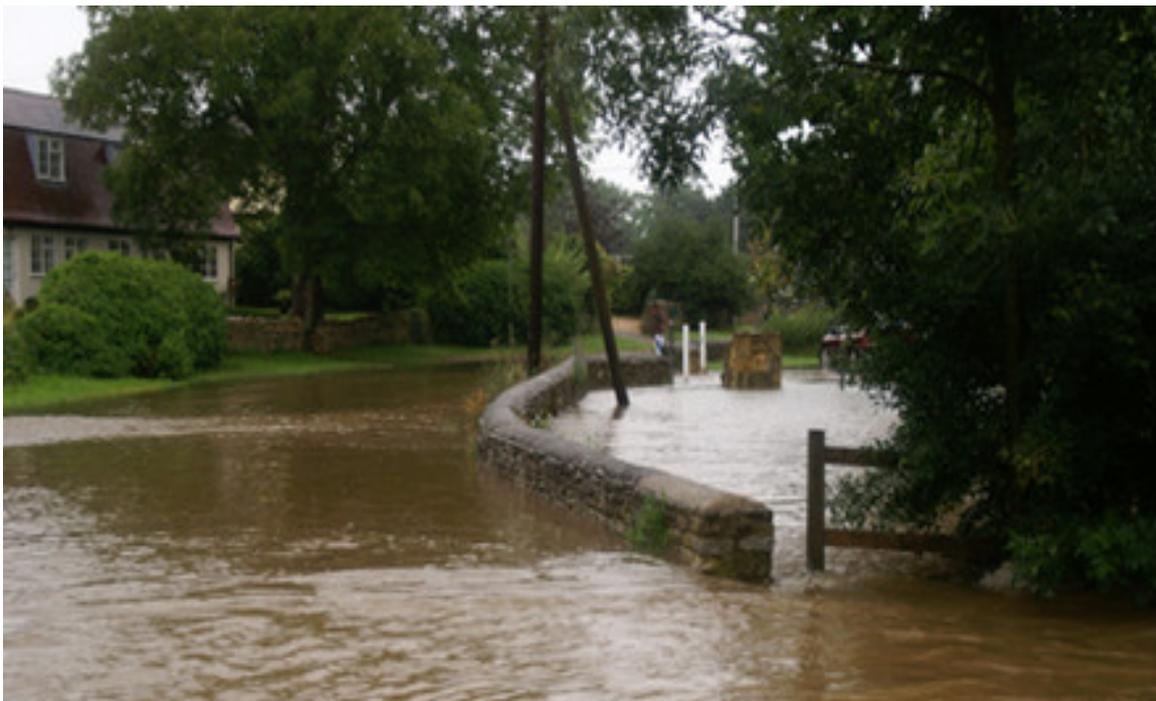
Photo 18 – Looking along Station Road towards Eynsham in July 2007

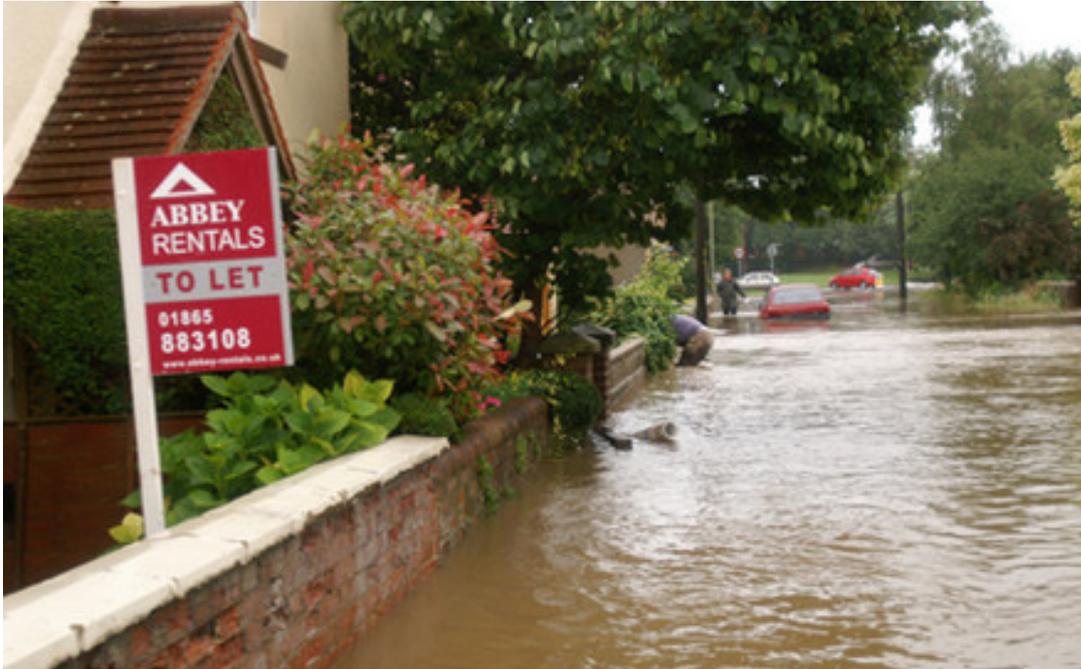
Photo 19 – Station Road Eynsham July 2007

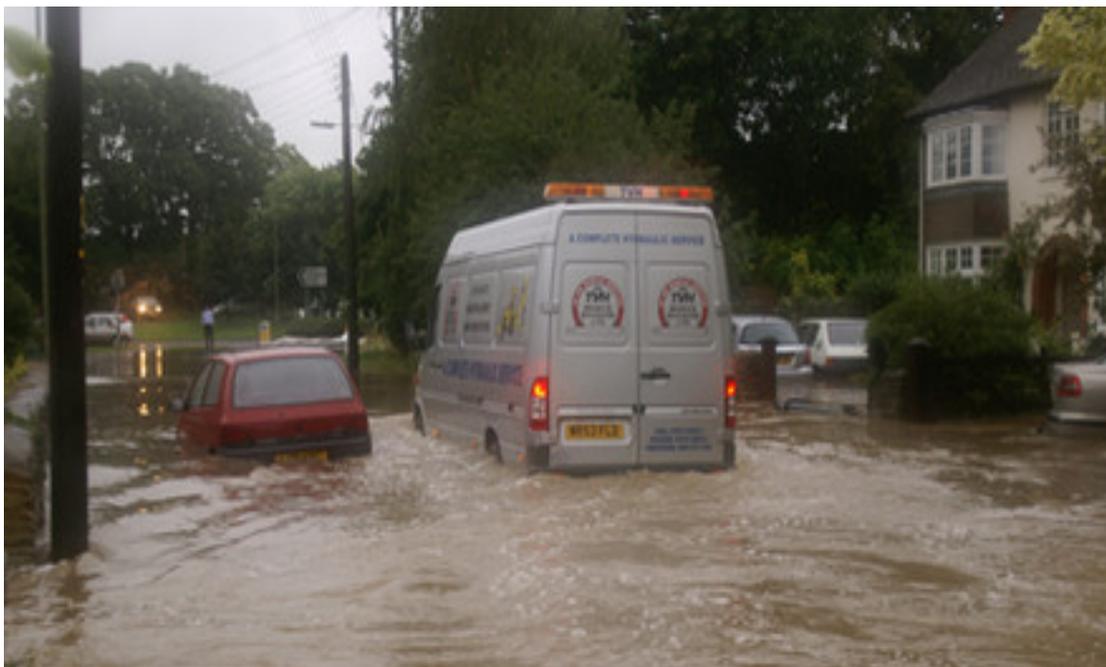
Photo 20 – Station Road, Eynsham July 2007

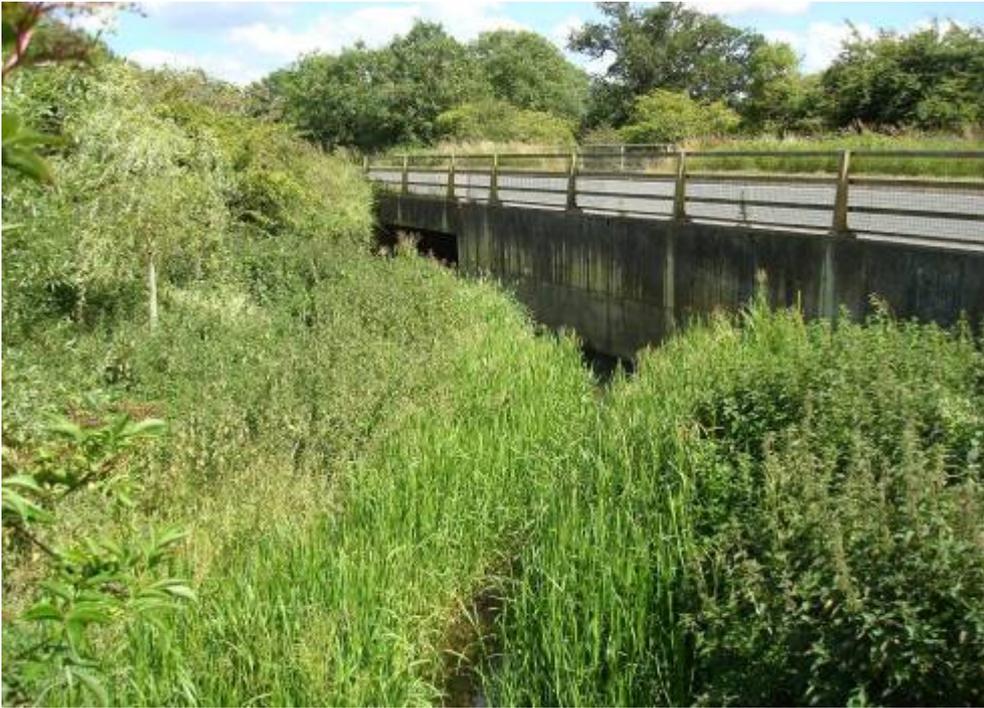
The Chil Brook runs parallel on its approach to and downstream from the B4449 bridge crossing forcing water through two 90 degree bends in the vicinity of the Recreation ground prior to flowing away (photos 21 to 26). During periods of heavy rainfall, levels in the Chil Brook rise significantly in a short period of time and the angle of this bridge prevents maximum flows crossing the B4449. Water instead backs up behind the bridge and flows out of bank, across the recreation ground and into property. It is noted that this bridge has a larger capacity to pass water, than the original rail bridge.

Photo 21 – Looking downstream towards B4449 bridge crossing. Photo shows growth in channel and the angle of approach to bridge crossing

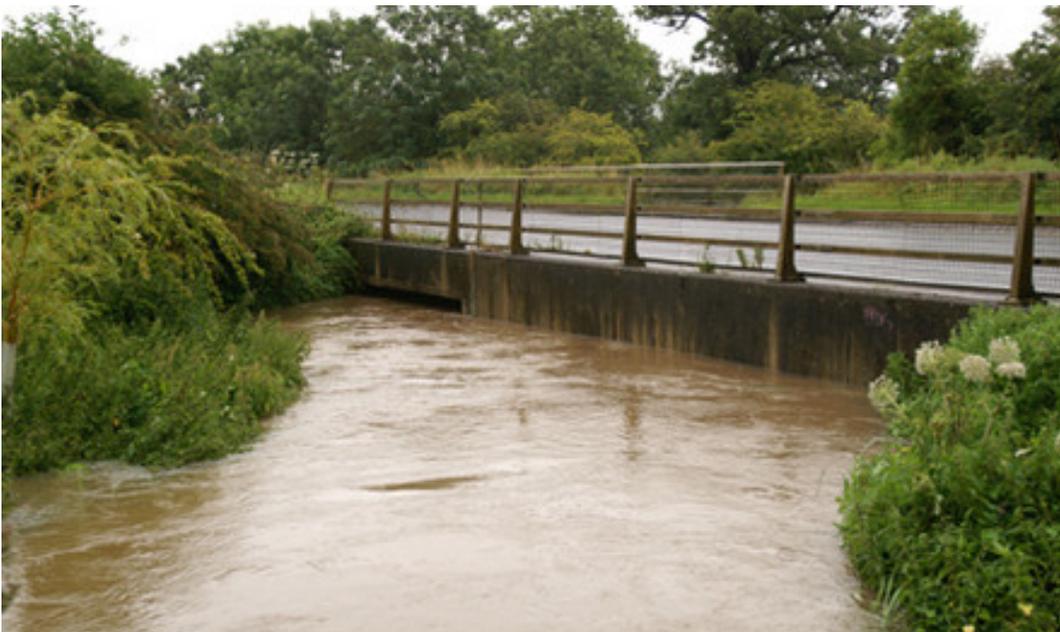
Photo 22 – B4449 bridge crossing July 2007

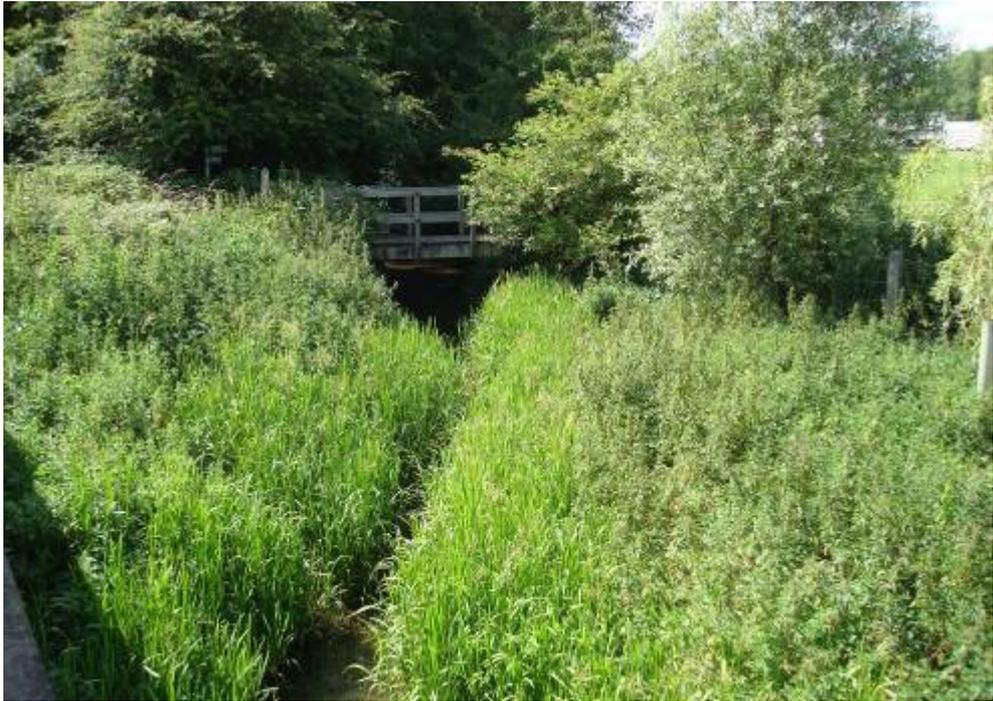
Photo 23 – B4449 bridge crossing looking upstream along the Chil Brook

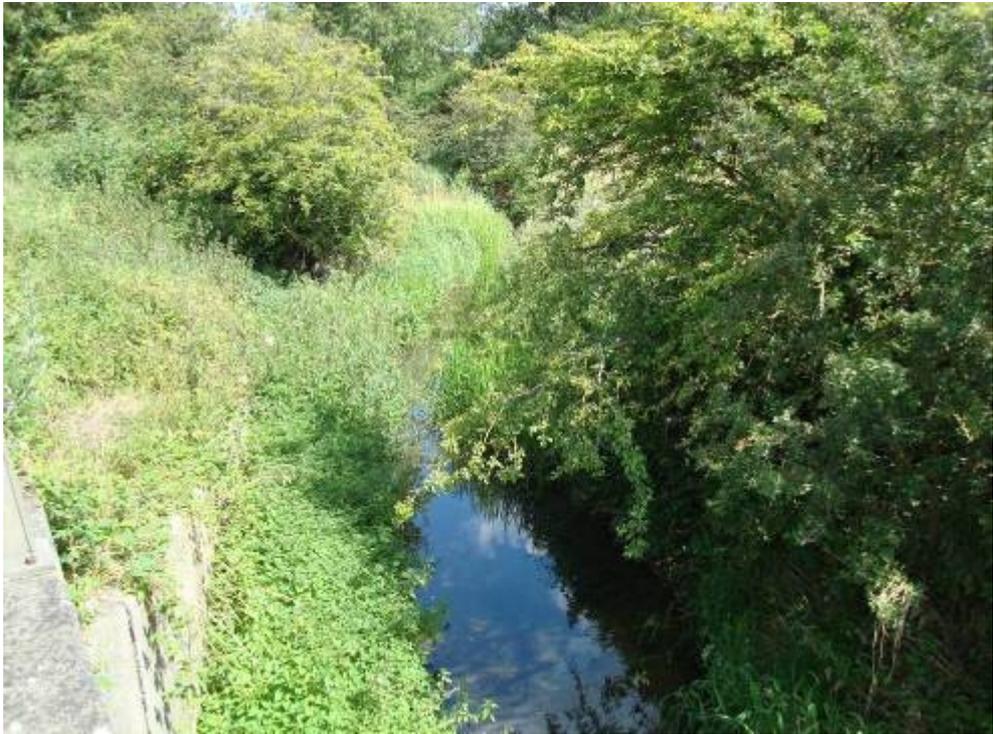
Photo 24 – Standing on the B4449 road bridge looking downstream along Chil Brook

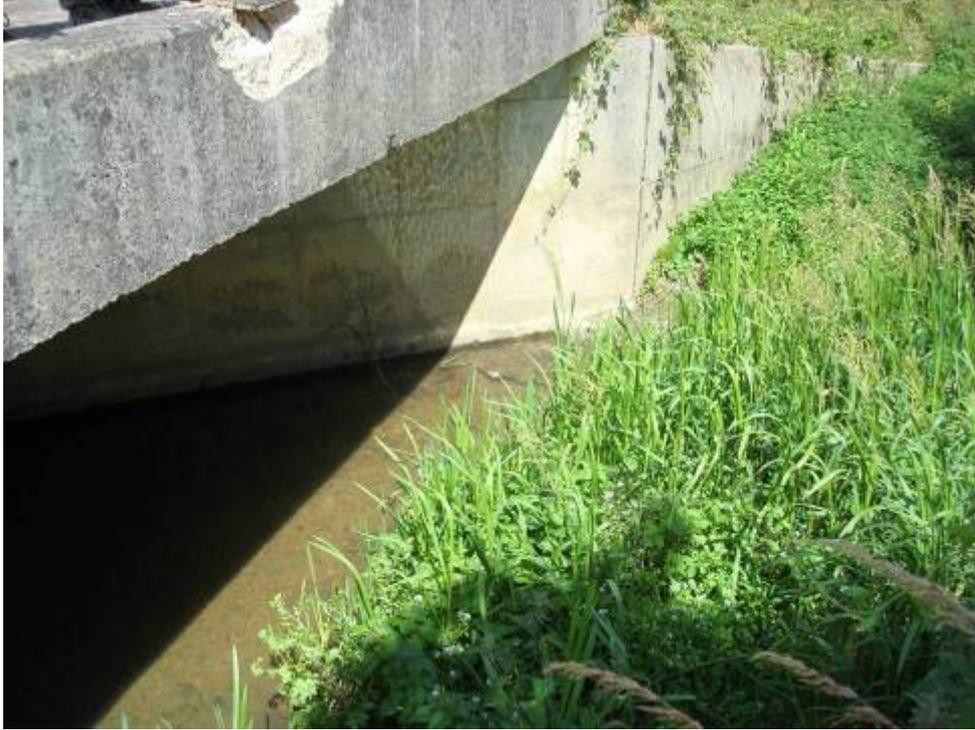
Photo 25 – Downstream face of B4449 road bridge

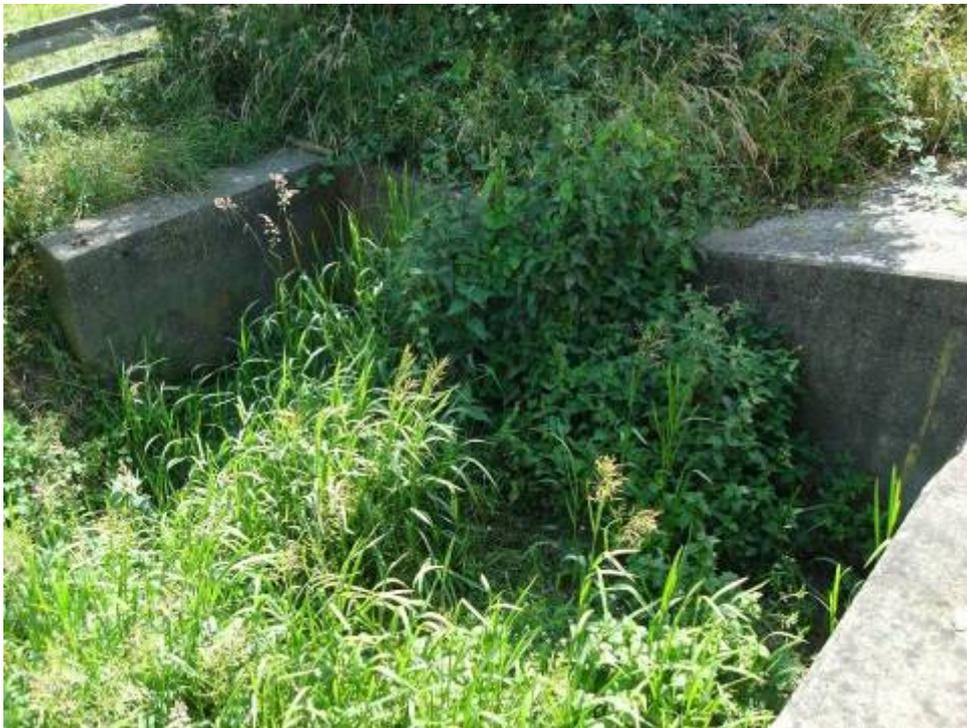
Photo 26 – Downstream of B4449 road bridge.
