WEST OXFORDSHIRE  
DISTRICT COUNCIL

# Parish Flood Report: **Alvescot**

July 2008

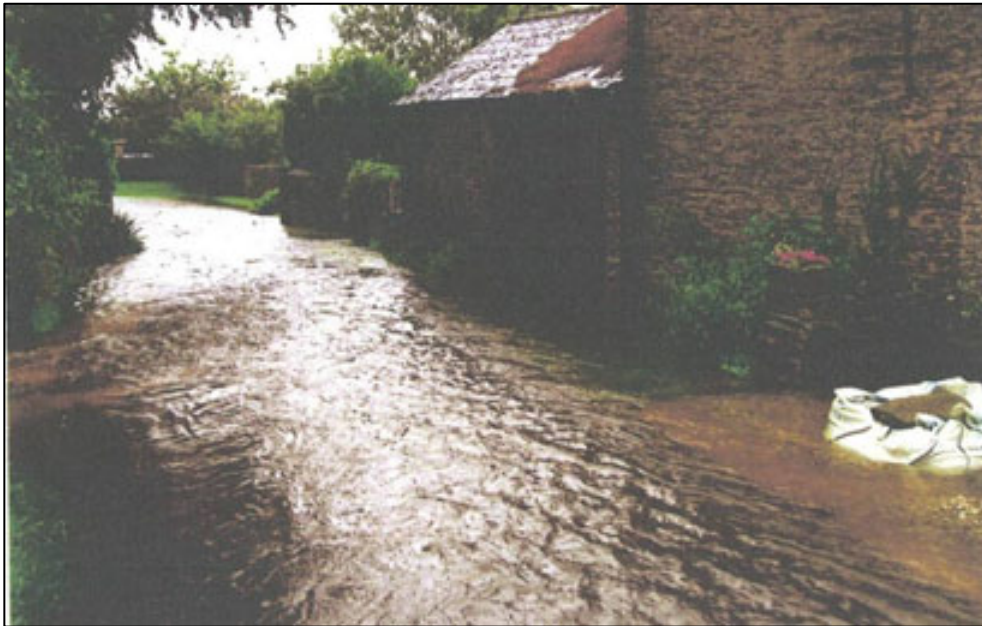
Photo 1 – Mill Lane looking towards Mill House, July 2007

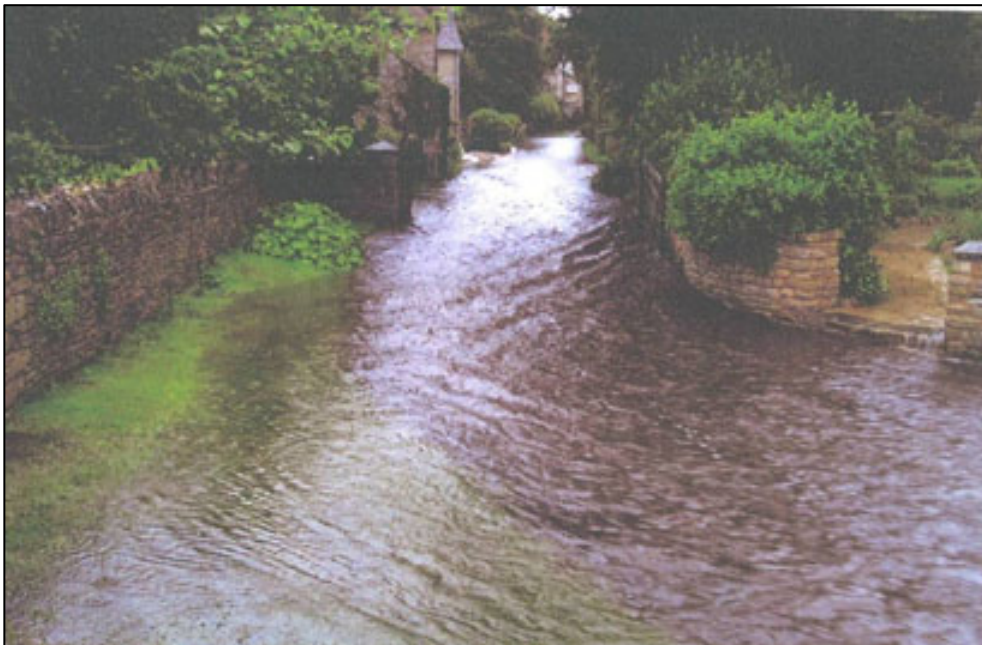
Photo 2 – Mill Lane, looking from Mill House back up the Lane – July 2007

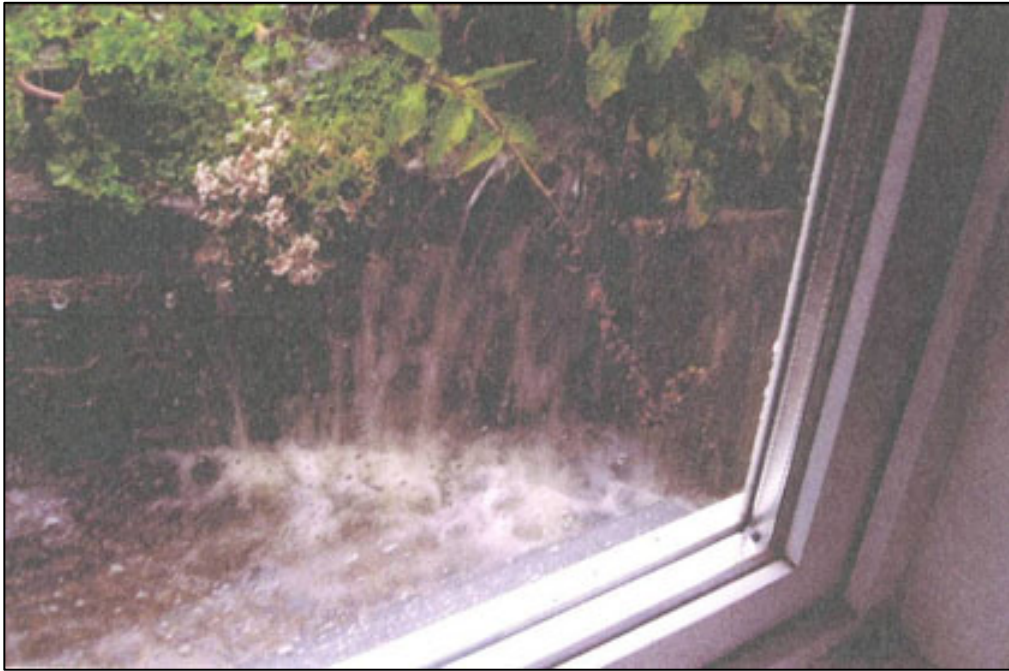
Photo 3 – Flood waters from farmland at the rear of properties on Mill Lane – July 2007

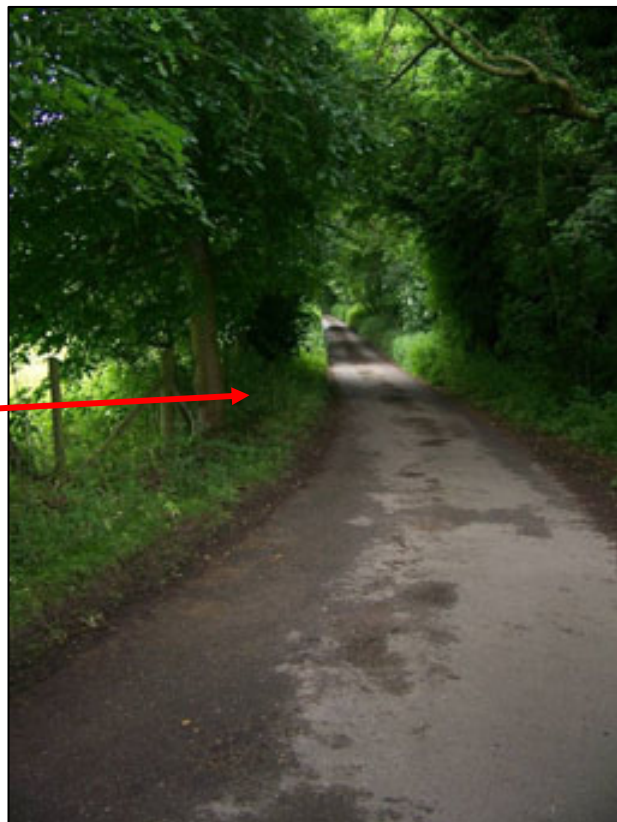
Photo 4 – Ditching along Mill Lane.

Historic location of  
ditch, now overgrown

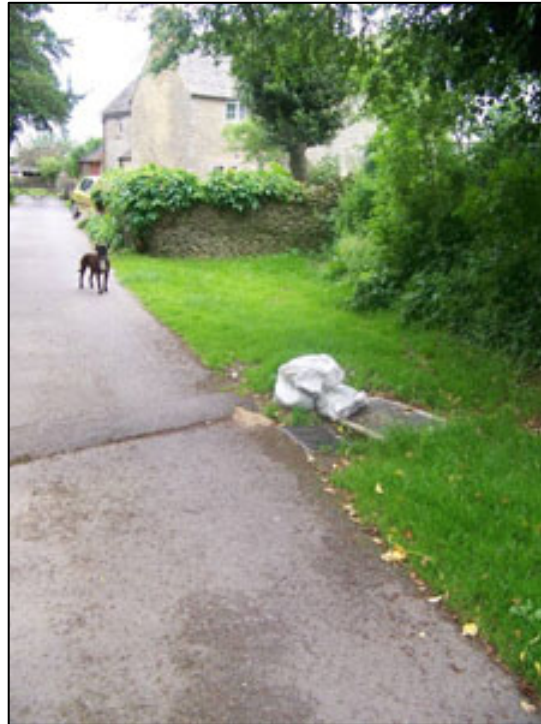
Photo 5 – Highway drainage gulley located at the end of Mill Lane, connects to the Shill Brook.

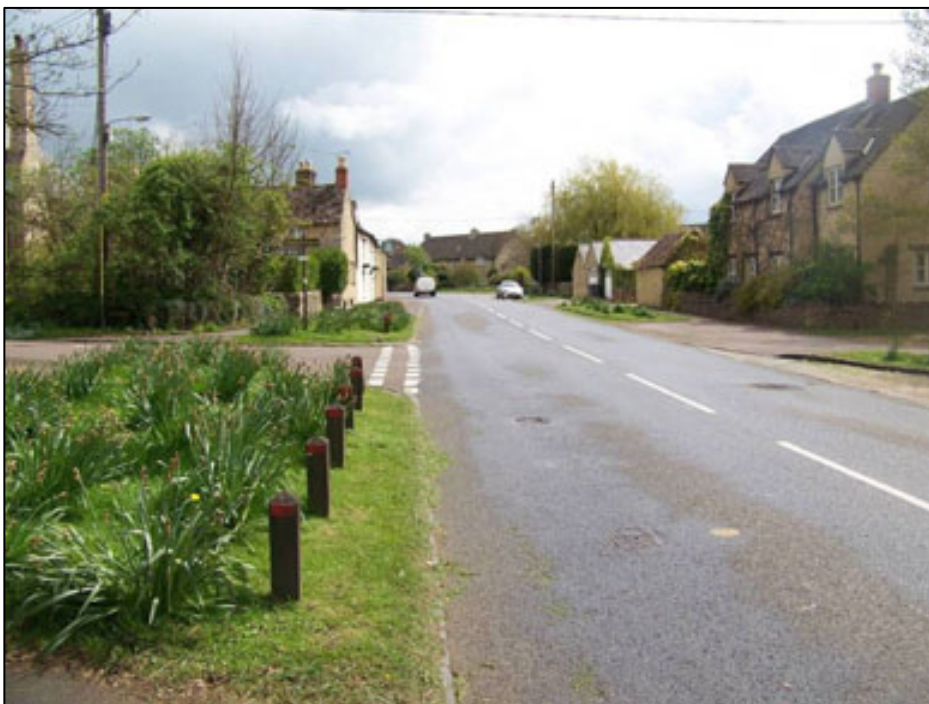
Photo 6: Station Road with Mill Lane on the left. This photo shows the low kerb line and level of property in relation to Station Road.

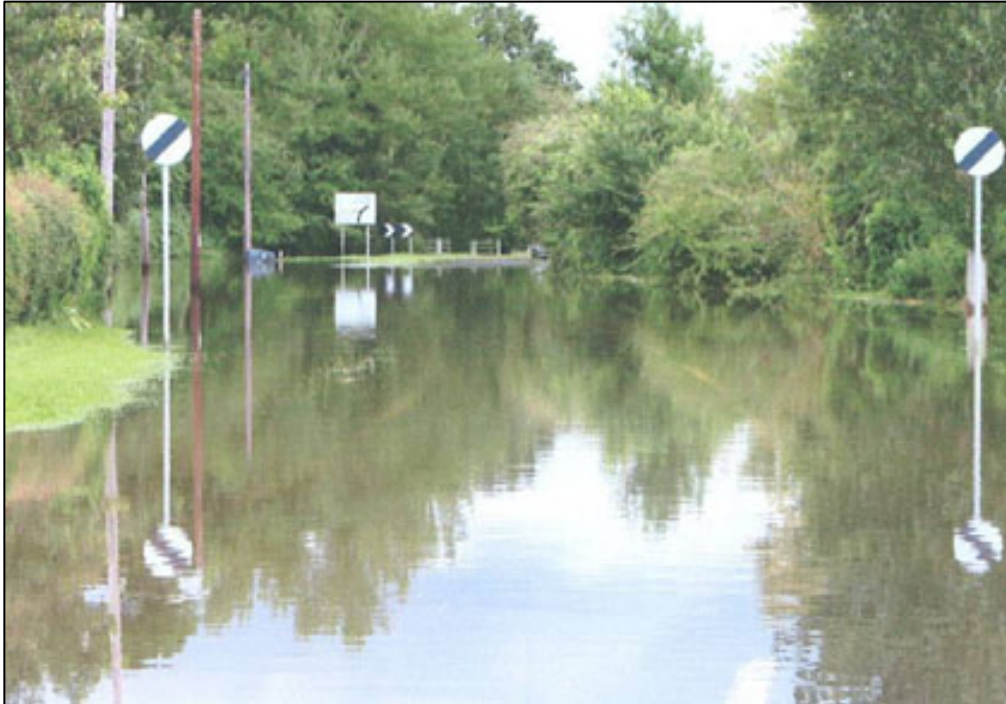
Photo 7 - Station Road - :Looking towards Black Bourton – July 2007

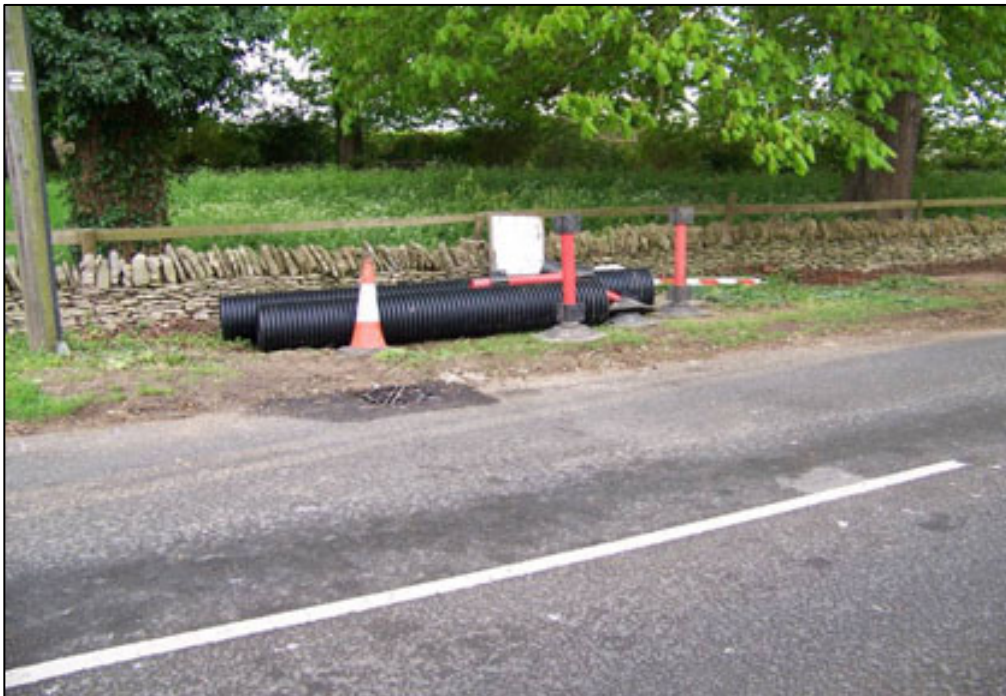
Photo 8 – OCC highway drainage being installed on Station Road – May 2008

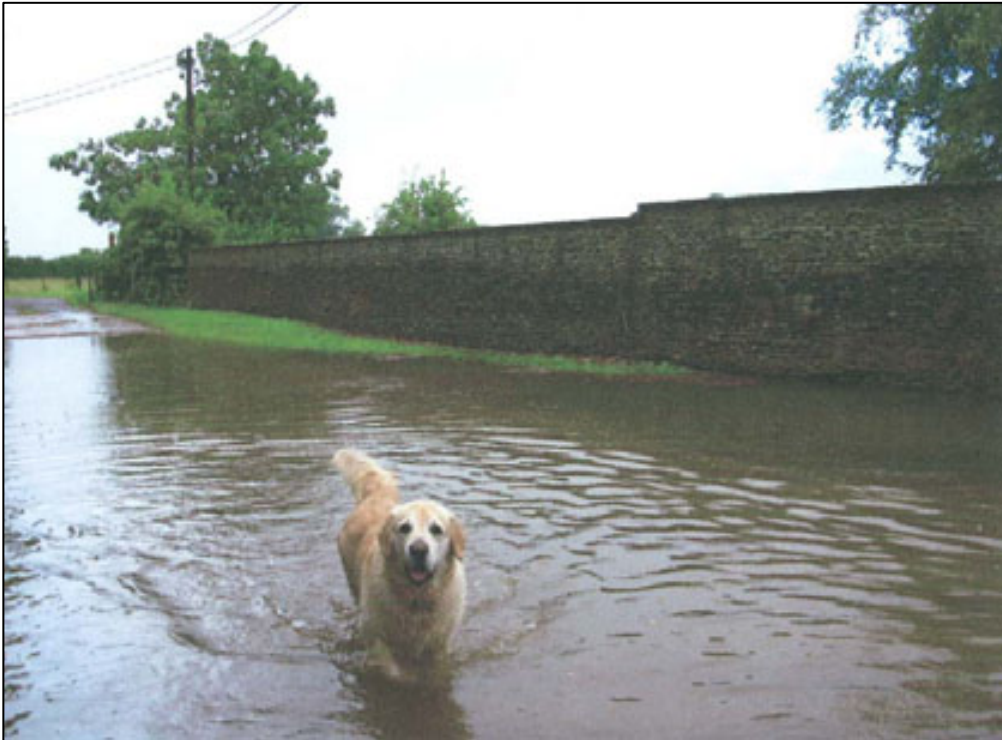
Photo 9 - Looking towards the TW pumping station at Lower End

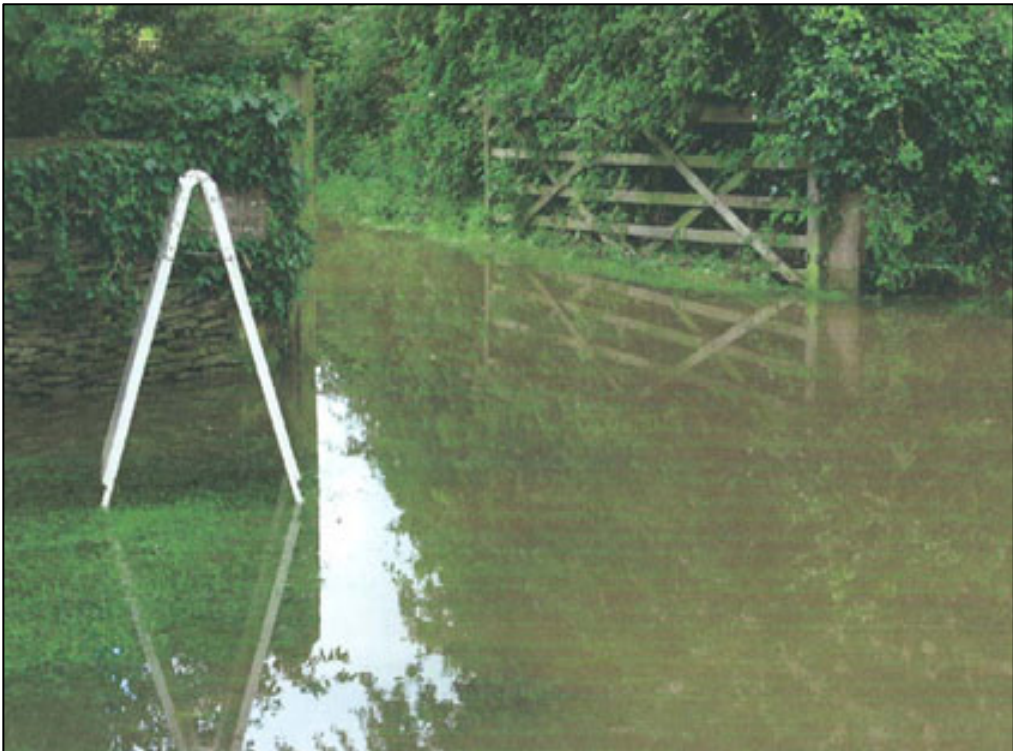
Photo 10 - Driveway to Stone Cottage, Lower End

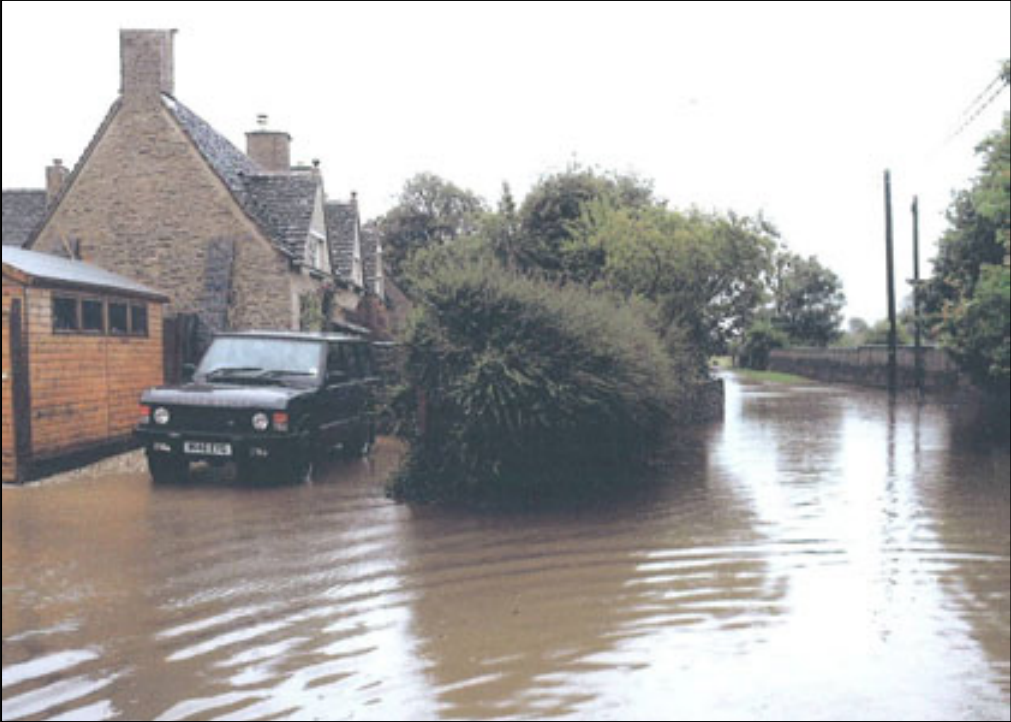
Photo 11 - Flooding of Lower End

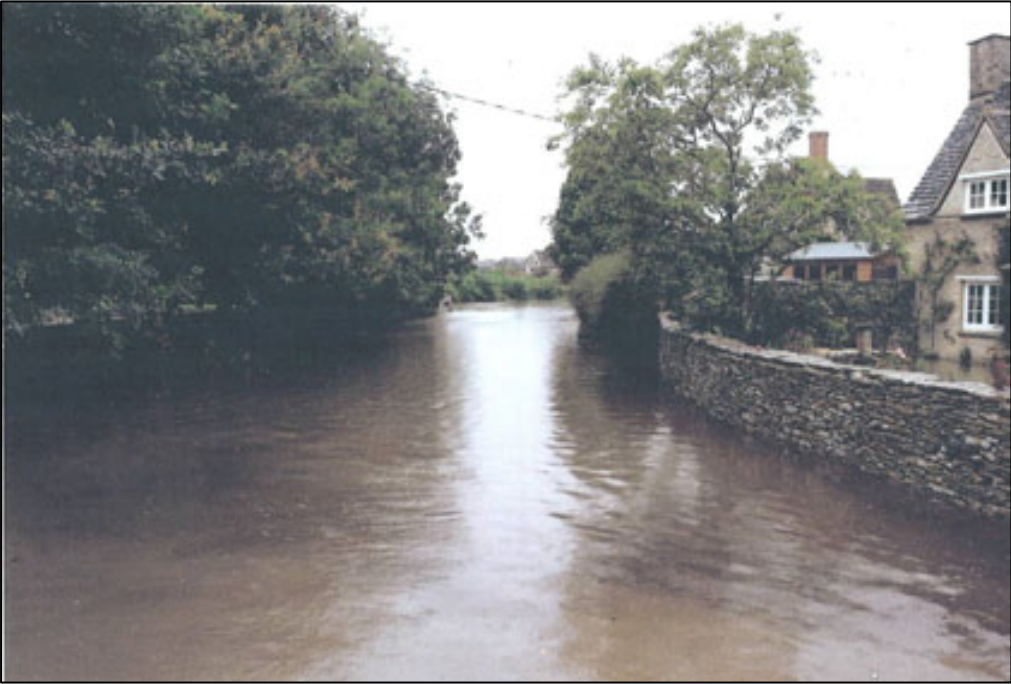
Photo 12 - Flooding Lower End looking towards Station Road

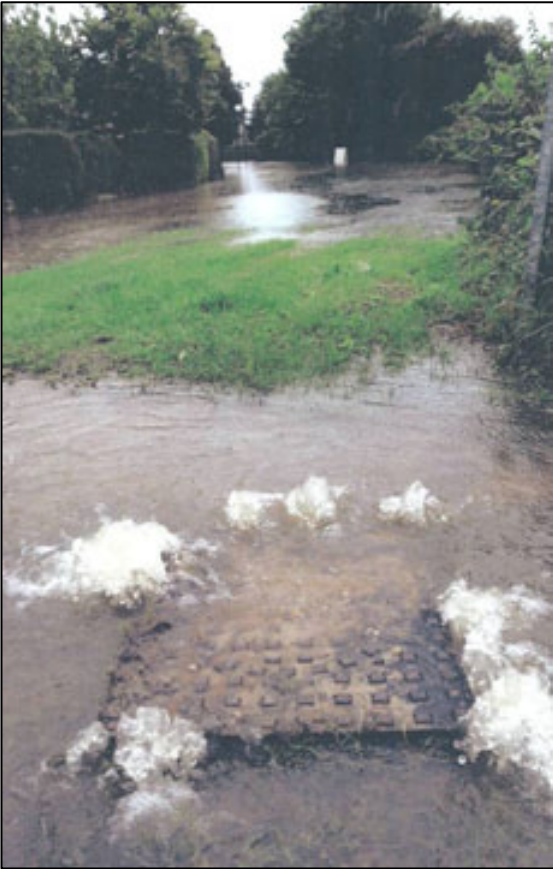
Photo 13 – Manhole surcharging at Lower End

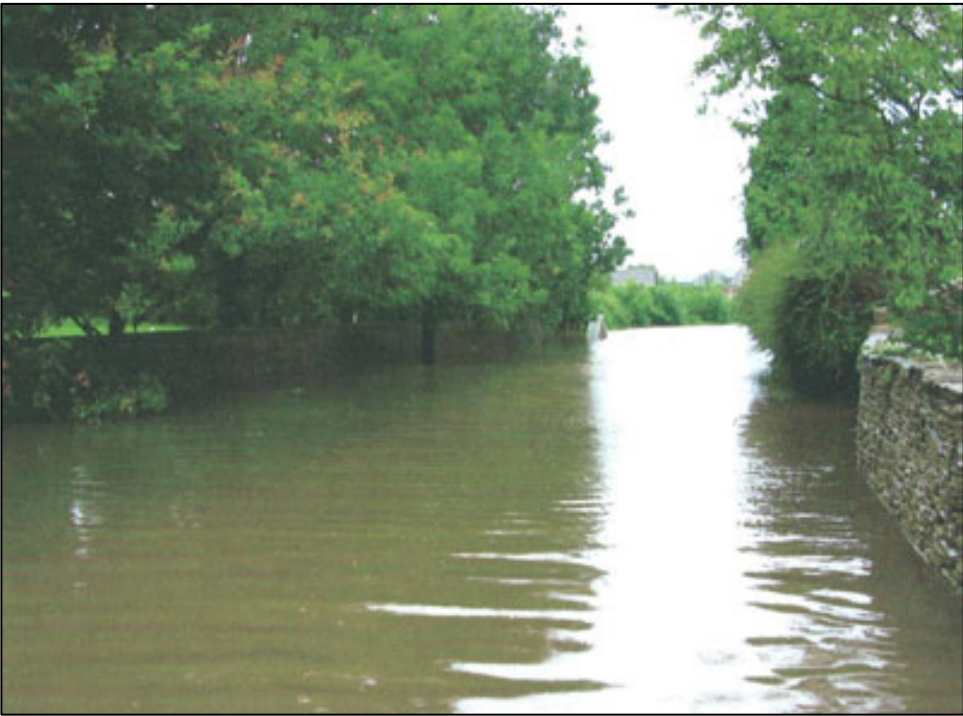
Photo 14 –Lower End looking towards Station Road

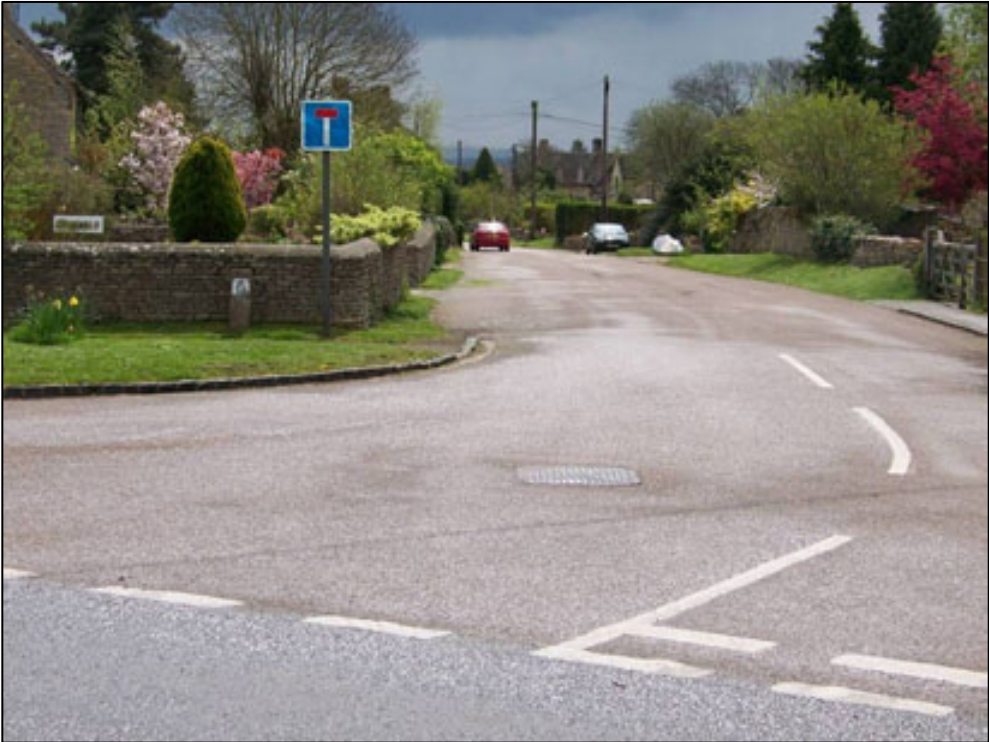
Photo 15 – Station Road looking down the lane to Lower End. This shows that the levels of the road mean that all of the surface water from this location will collect in the low point at Lower End.
