WEST OXFORDSHIRE  
DISTRICT COUNCIL

# Parish Flood Report: **Carterton**

May 2008

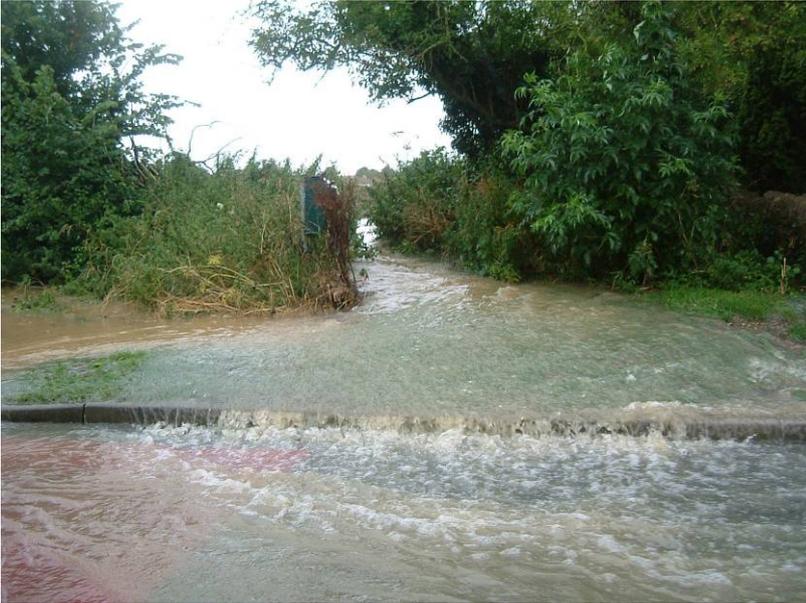
**Area 1 – Shilton road (B4020) and Strathmoor Close**

Direct overland flow and ponding affected Shilton Road to the north west of the town. Direct overland flow occurs when the ground either becomes fully saturated, preventing any percolation into the upper layers of soil, or where the rainfall intensity and rate is greater than the percolation rate of the receiving ground. Both result in sheet runoff, or water flowing directly off the surface of the land.

Direct runoff from fields adjacent to Shilton road, flowed downhill along the road and towards Carterton. This contributed to the surface water flooding issues and resulted in some lower level properties being flooded.

26 properties made grant applications to WODC following the July floods and all were affected by flooding as a result of surface water runoff and overland flow. During the course of the heavy rain in July 2007, ponding was observed on numerous roads throughout the town. As the rainfall intensity increased, the surface water drains and gullies began to surcharge and water flowed down roads, increasing in depth until kerbs and drives were overtopped and properties with lower floor levels were flooded.

Several properties along Shilton Road and Strathmoor close were affected by surface water flooding.

Flooding at Shilton Road

The following on-going maintenance is recommended (Option A):

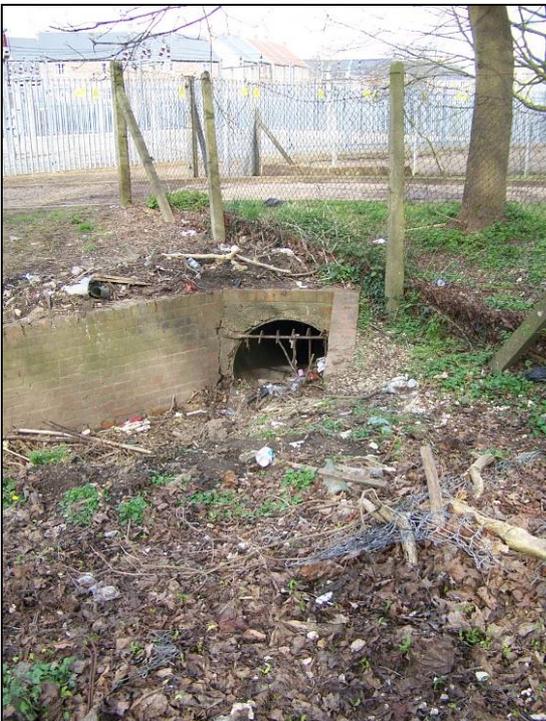
**Area 2 – Northwood Crescent, Manahan Road and West Oxon Industrial Estate**

The access track to the substation crosses the ditch over a bridge (see photos in Appendix 2). The ditch is culverted under the bridge through a circular concrete pipe approximately 0.6 m in diameter and 3.5 m in length. The inlet is estimated to be approximately 40% blocked and the channel immediately upstream contains a lot of debris. Water backs up behind the culvert inlet and overflows onto the banks, bridge deck and the substation. Channel and culvert clearance would reduce the impact of flooding in the area.

On informal footpath has formed adjacent to the substation. In order to cross the ditch debris is placed in the channel, creating a blockage and potential flood risk to the substation.

Culvert on approach to Substation looking downstream

- Replace piped culvert with a larger box culvert or clear span bridge to increase capacity of crossing (Option B).

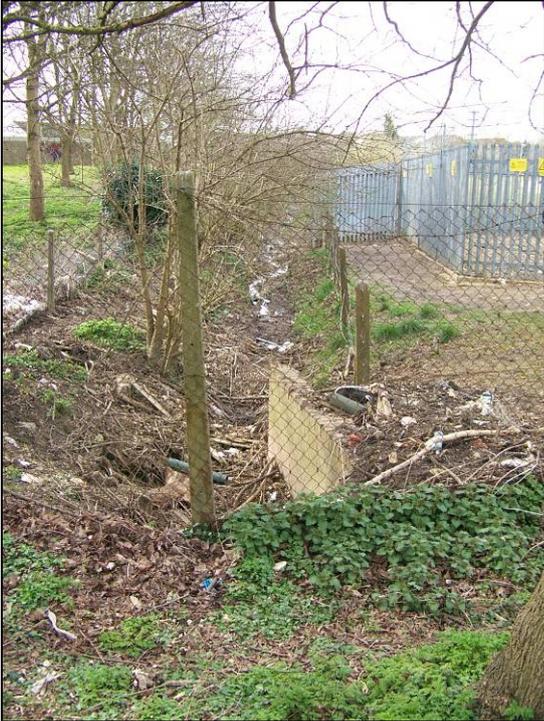
Although there are no reports of property flooding that has been solely attributed to watercourses, the Town Council and several residents have reported that the ditch (ordinary watercourse) flowing in a south easterly direction to the north of the town has overtopped on several occasions. The ditch is very overgrown and is, in places, almost completely blocked with debris. WODC cleared a 600m stretch of the watercourse in 2007. However, some significant debris blockages have built up again.

The electricity substation (Southern Electric) near Northwood Crescent was surrounded by water in July 2007 on several occasions, though the equipment did not actually flood. However, these reports highlight a potentially very serious flood risk to critical infrastructure in Carterton – should the substation flood, and be shut down as a consequence, the whole of the town would be without electricity (confirmed by Southern Electric 02.05.08).

Evidence of sewer flooding has also been observed at the electricity substation on Northwood Crescent. Sewer detritus was observed around a manhole, in the channel and on the banks of the watercourse. A combined sewer overflow (CSO) is present nearby and that this operates when water levels in the ditch are high. The MOD are responsible for the CSO and manhole.

Ditch at north of Carterton near substation.

The following on-going maintenance measures are recommended for the ditch/watercourse flowing through the North of the town (Option A).

- Option C – As part of the investigative process, it is recommended that an individual flood study is carried out on the ditch so that extreme water levels can be determined and the actual risks to the areas adjacent to the ditch can be defined more accurately. Using this information, flood defences and or flood warnings can be implemented.
- Option D – The MOD should be approached to repair/upgrade the sewer overflow at the ditch on Northwood Crescent.

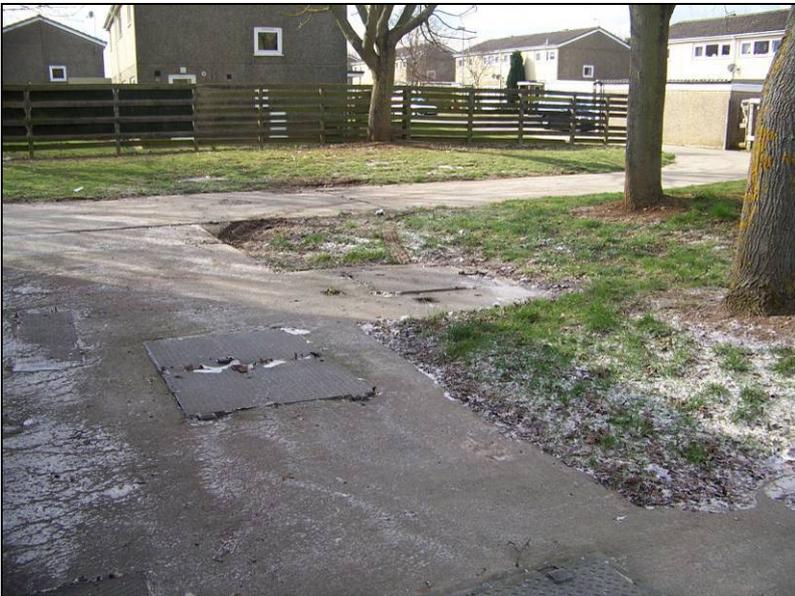
**Area 3 – School, Selwood Drive and Halton Road**

One case of combined sewer and surface water flooding has been reported in the vicinity of Halton Road and Hastings Drive. There is a Thames Water pumping station (See Photos in Appendix I) in the area and residents and Thames Water say this was overwhelmed in July 2007.

Halton Drive near SPS

- Option A. Sewer flooding in July 2007 at Halton Road and Hastings Drive can be attributed to the Sewerage Pumping Station (SPS) - Carterton Halton Road SPS – CARTP3ZZ - being overwhelmed. This needs to be confirmed with Thames Water. It is recommended that TW assess the feasibility of undertaking improvements works.

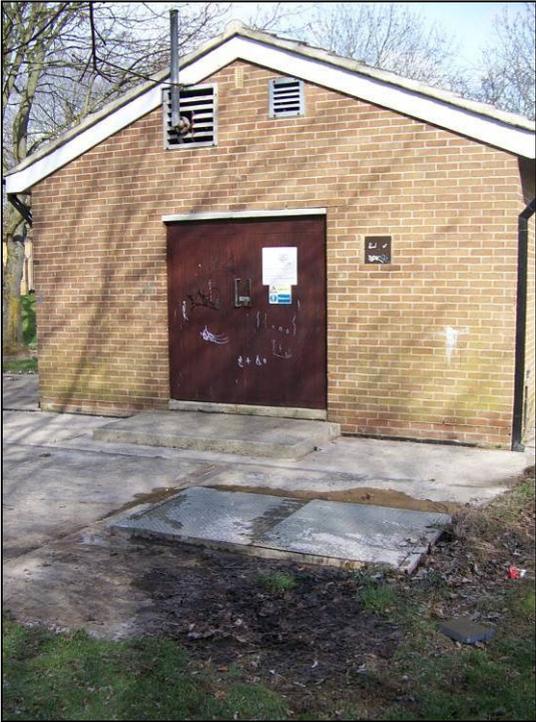
Halton Drive SPS
