WEST OXFORDSHIRE  
DISTRICT COUNCIL

# Parish Flood Report: **Clanfield**

May 2008

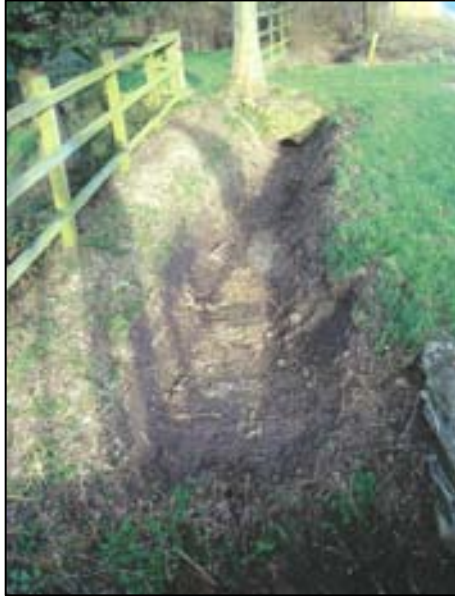
Photograph 3: Bampton Road drainage channel opposite Marsh Lane. The photograph shows the small ditch following clearance by OCC but prior to removal of the tree whose roots block the culvert. This has since been completed by WODC.

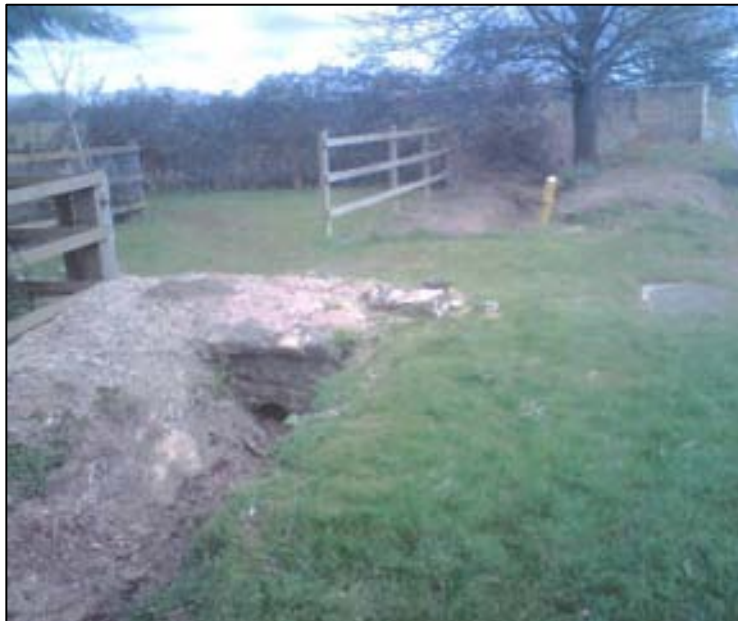
Photograph 4: Bampton Road drainage channel opposite Marsh Lane. This photograph was taken following works by WODC to remove the tree.

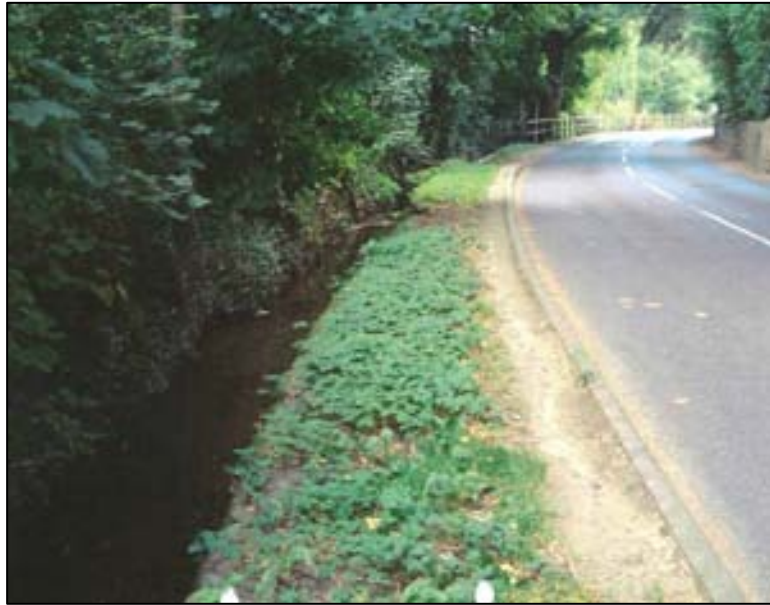
Photograph 5: The Clanfield Brook at Black Bourton Bends

Flooding on the Black Bourton Road between Calcroft Lane and Main Street was primarily caused by the Clanfield Brook. The Clanfield Brook runs parallel to the Calcroft Lane and crosses the Black Bourton Road via a piped culvert before turning sharply to run parallel to the Black Bourton Road.

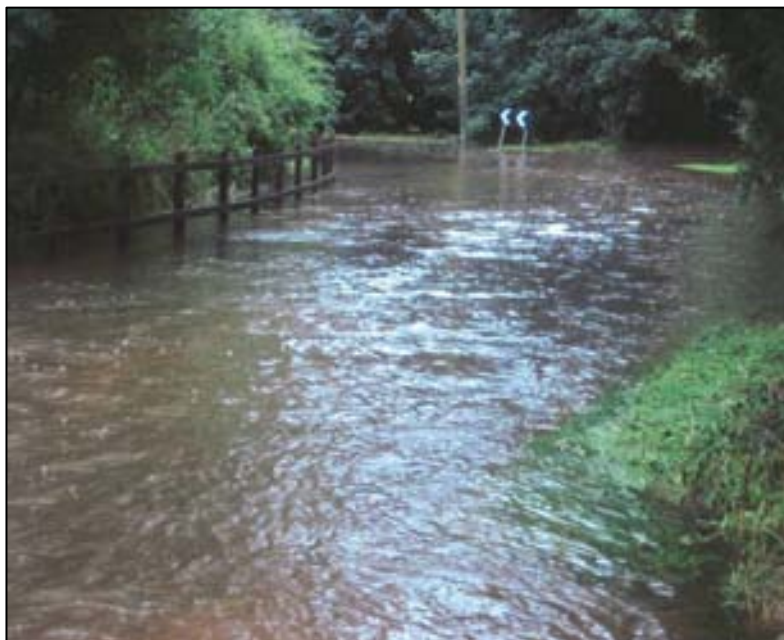
Photograph 6: The Black Bourton Bends in flood, July 2007.

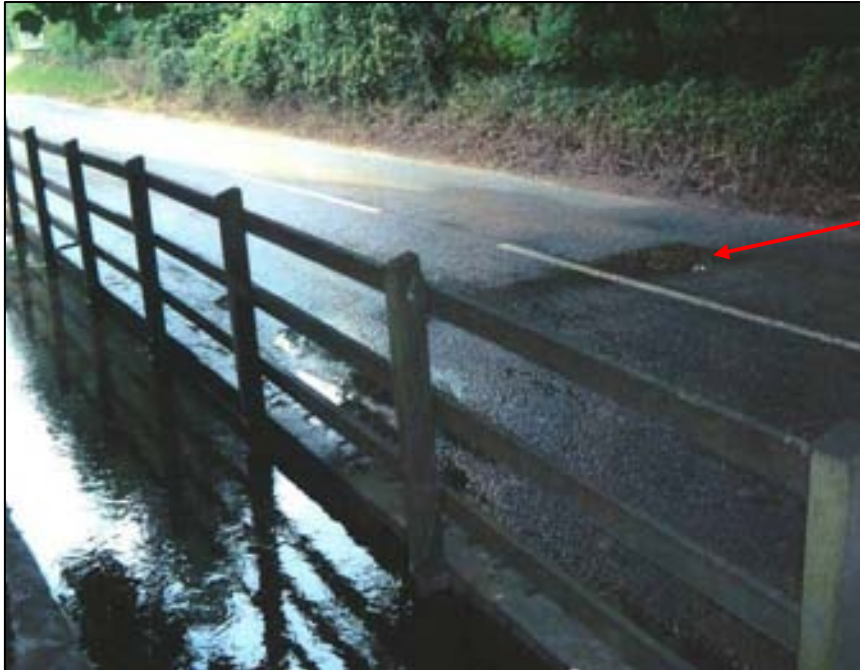
BT own a manhole located on the Black Bourton Bends just south of the Chestlion Farm access. This manhole regularly leaks water onto the Black Bourton Road, even when the rest of the road is dry. During the winter months this water freezes causing a hazard to motorists and pedestrians. During periods of prolonged rainfall water rushes from the manhole contributing to flooding of the Black Bourton Road.

Photograph 7: BT Manhole leaking at Black Bourton Bends

Leaking BT manhole

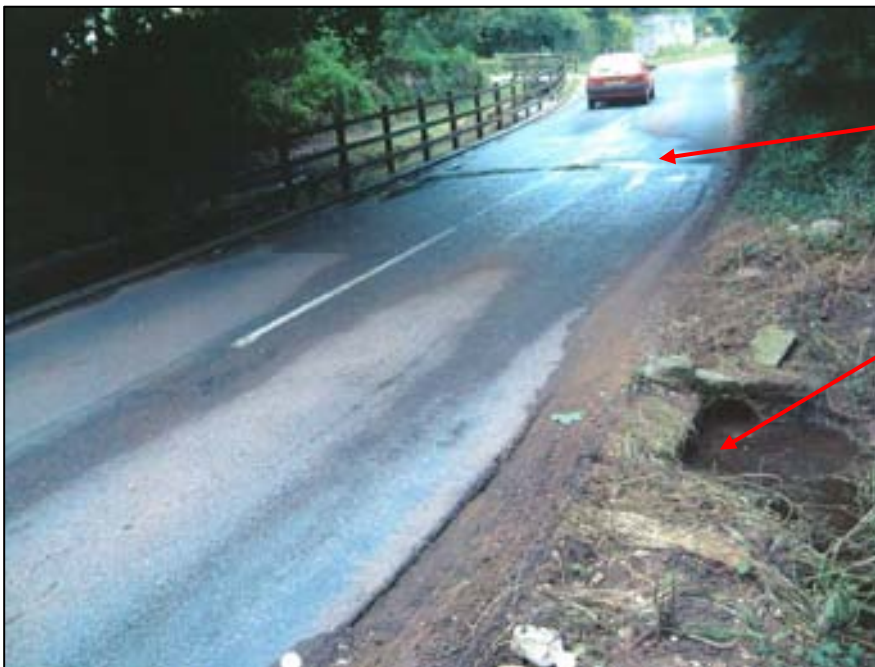
During periods of prolonged heavy rainfall flooding occurs on the Black Bourton Road between the Plough Hotel and Chestlion Lane. There are two causes. Firstly, poor maintenance and subsequent blockage of the drainage ditch located on the west of the road then allows water to flow directly onto the road. Secondly, the Clanfield Brook is exceptionally narrow and shallow at this point and often floods. (See photographs 8 and 9)

Photograph 8: BT manhole at Black Bourton Bends and drainage ditch at end of Chestlion Farm

Leaking BT manhole

OCC to complete initial ditch maintenance and increase culvert size under road. Riparian owners are responsible for future maintenance.

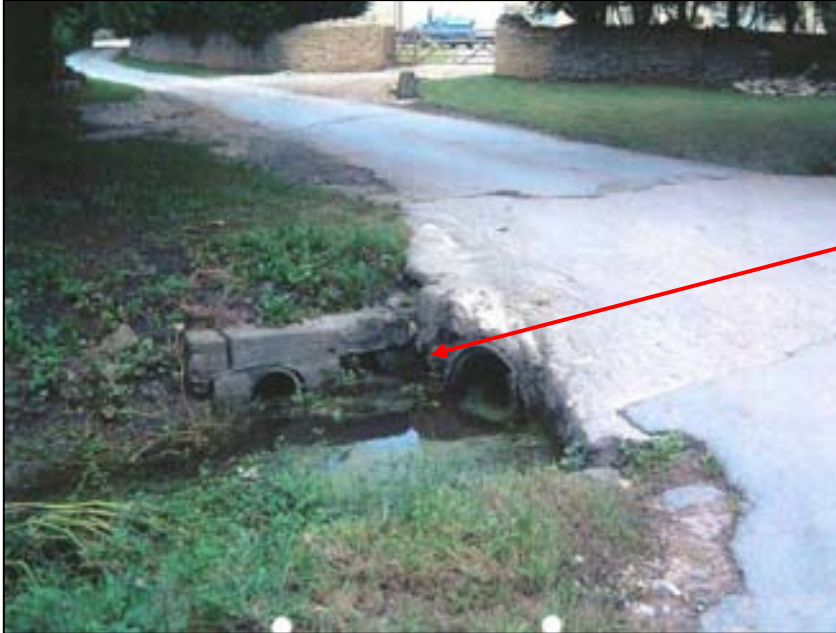
Photograph 9: Drainage ditch at end of Chestlion Farm on Black Bourton Bends

OCC to complete initial ditch maintenance and increase culvert size under road. Riparian owners are responsible for future maintenance.

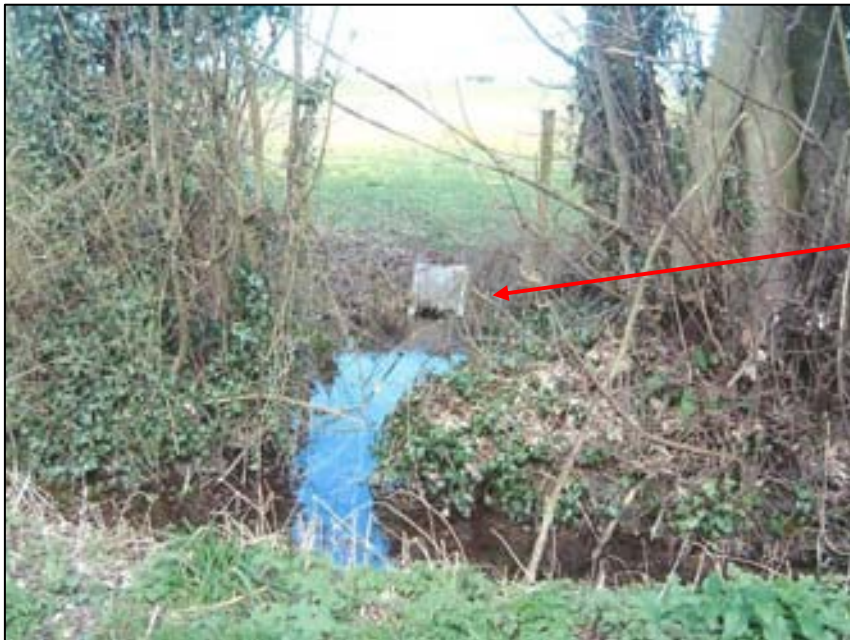
Photograph 10: Spring located to the north of Calcroft Lane flowing to Clanfield Brook

Land drainage outfall on north of Calcroft Lane

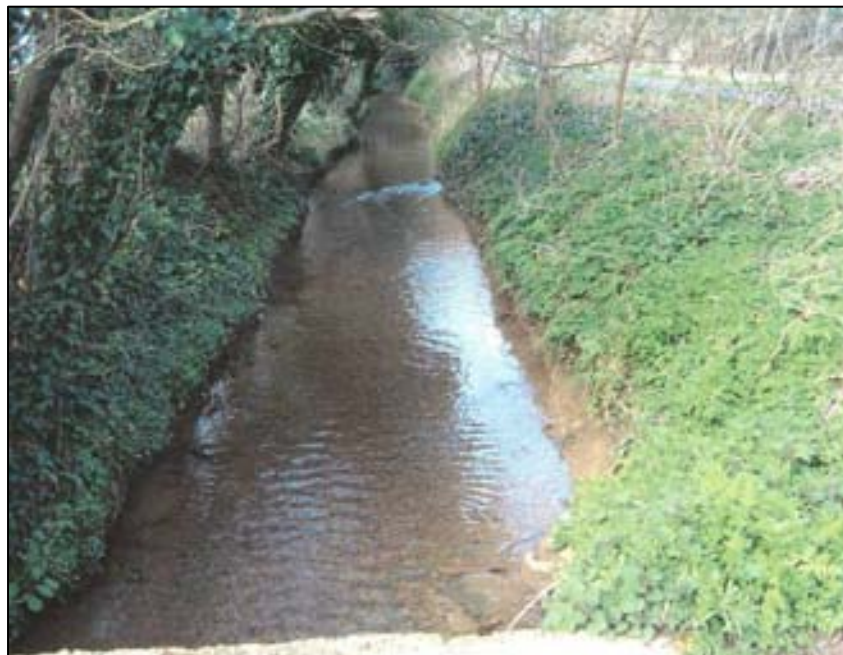
Photograph 12: Clanfield Brook running parallel to Calcroft Lane upstream of Black Bourton Bends

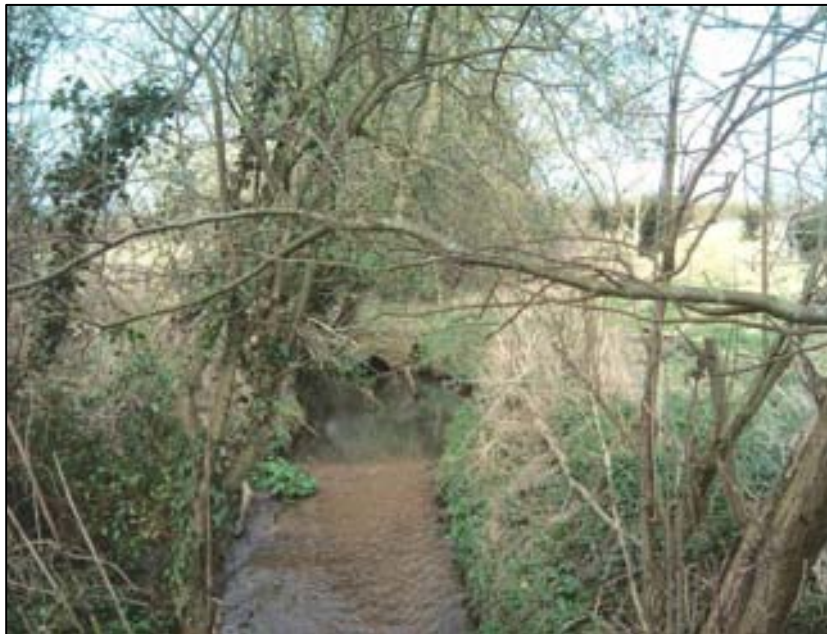
Photograph 13: Clanfield Brook upstream of Black Borton Bends  
This photograph shows restrictions in the upstream catchment near to Bazeland Farm

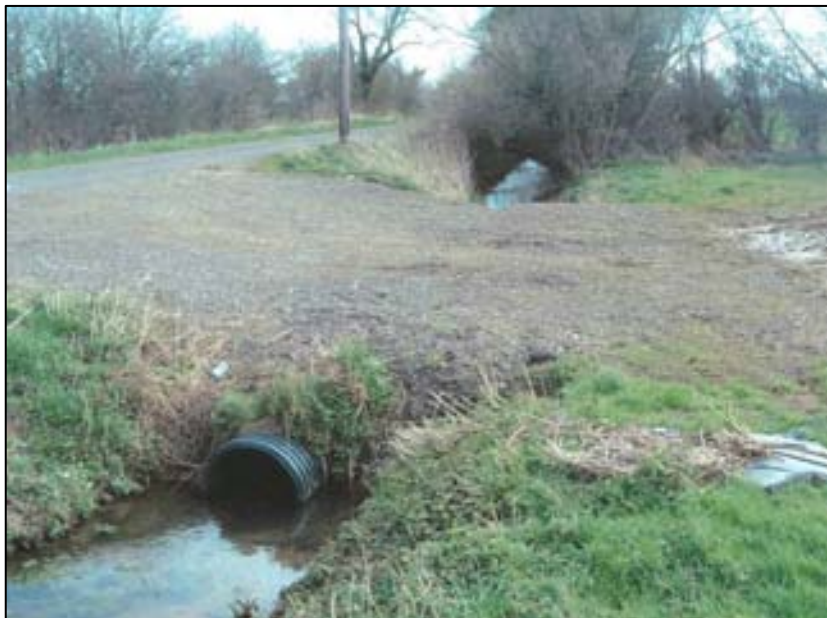
Photograph 14: Clanfield Brook running parallel to Calcroft Lane  
This photograph shows farm access restrictions to flow near to Bazeland Farm

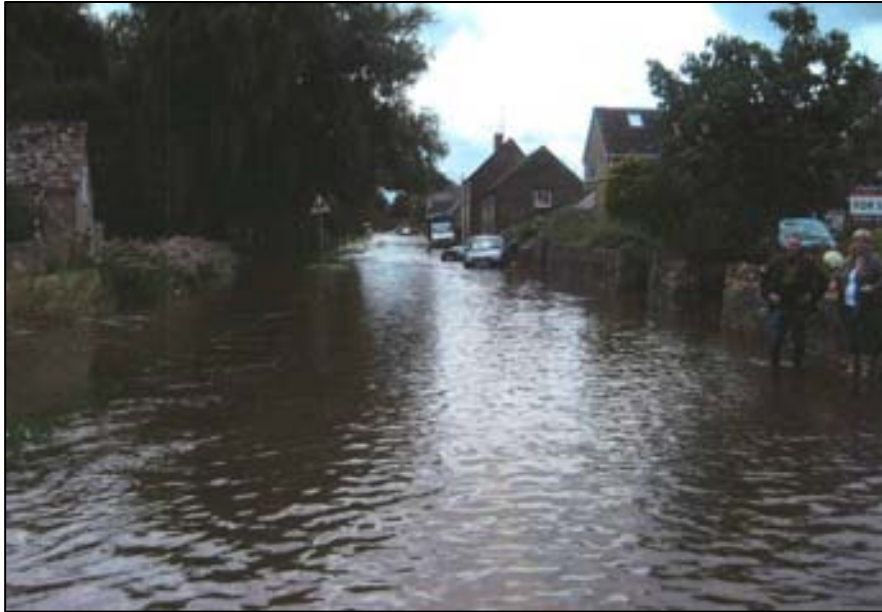
Photograph 15: Main Street Clanfield, July 2007

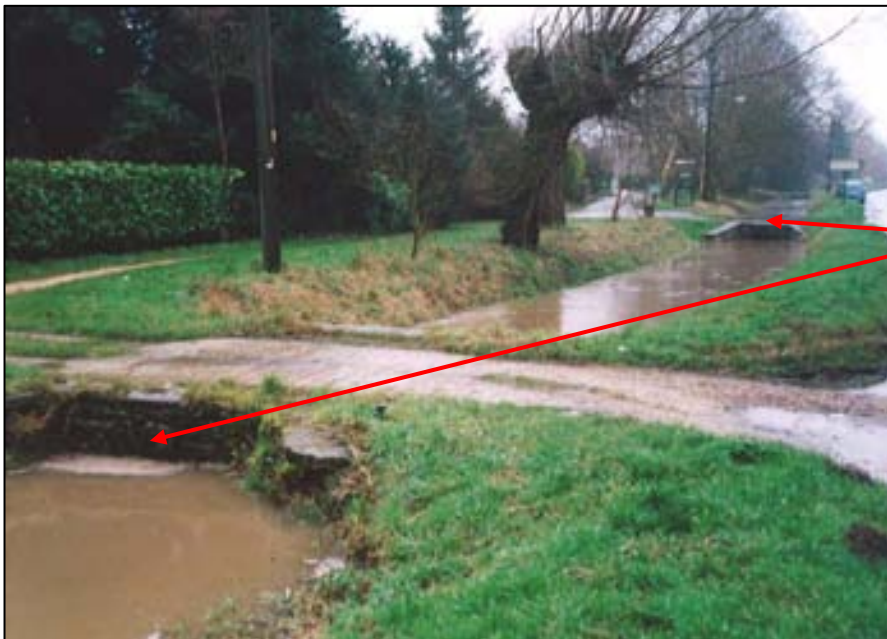
Photograph 16: Clanfield Brook, Main Street

On Main Street (Area 3), WODC has a record of 33 properties flooding during July 2007 and claiming flood grant aid. Flooding in this location is due to the Clanfield Brook which runs along the eastern side of the road and flood water from the Black Bourton Brook which during the July event, flowed down the Bampton Road onto Main Street. A number of bridges and driveways cross the Clanfield Brook restrict flows, further contributing to flooding (photograph 16).

This photograph shows the bridge restrictions on the Clanfield Brook at Main Street

Surcharged bridge crossings

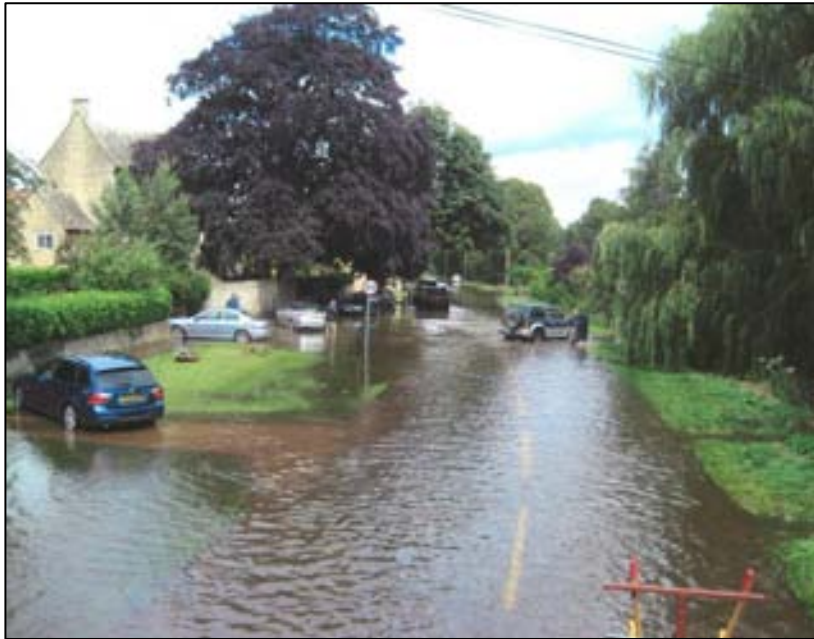
Photograph 17: Main Street Clanfield July 2007
