Parish Flood Report:

Chadlington

November 2008

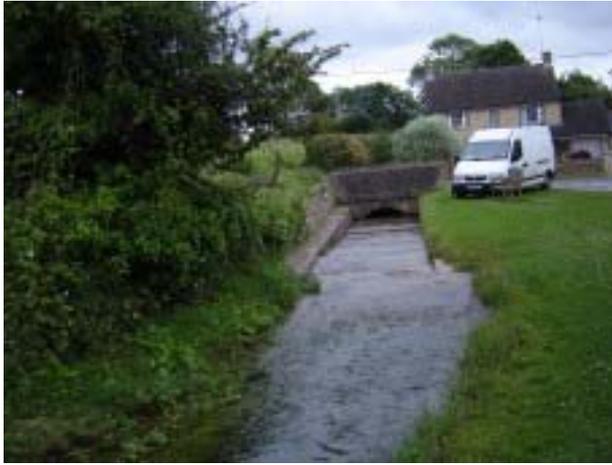
Build up of silt preventing the free passage of water through the six tier approach and culvert crossing at Brook End.

Area 1 - Brook course culvert Brook End

- Option 3 – OCC to Dredge out silt from channel and clear silt from culvert crossing for Bull Hill Stream at Brook End. OCC to undertake work as this is highway drainage and Bull Hill Stream is not Emained.

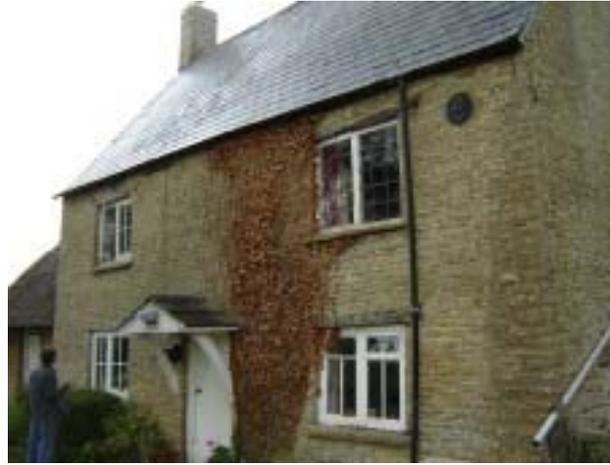
During periods of intense and prolonged rainfall the water table in the locality rises and there is water ingress through the porous walls and floor of Brook Place, Boot Cottage and some adjacent properties.

Area 2 - Boot Cottage

- Option 2 – Thames Water to survey sewer and remove all surface water connections from the combined sewer. This action will reduce the frequency of foul sewer flooding.
- Option 5 – Property owner to Relay stone floors using a hygroscopic membrane. Tank walls internally if required.

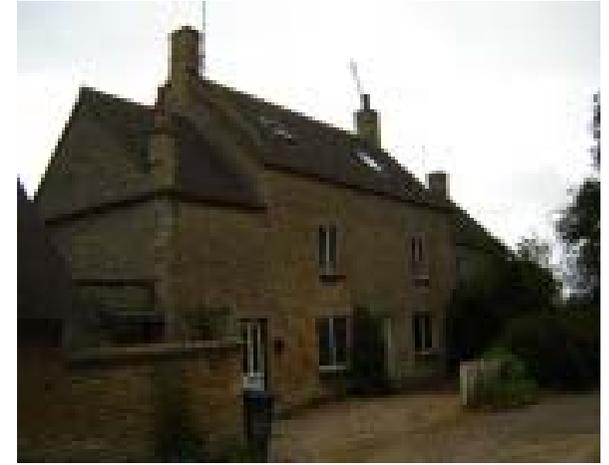
Area 2 - Brook Piece

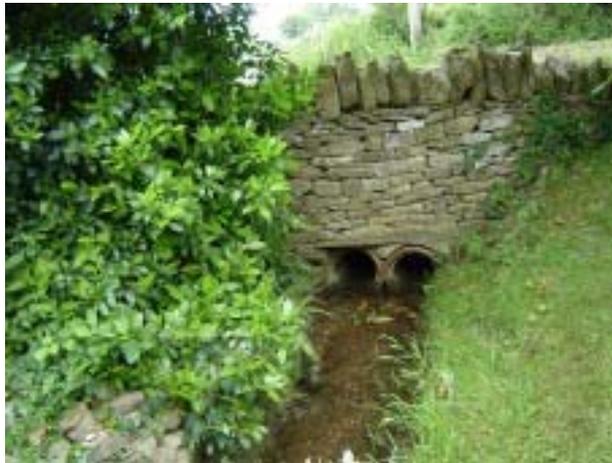
“Greywalls” flooded for two possible reasons: (i) Overland field run-off cascading through and over the garden boundary wall or (ii) Highway drainage flooding from a small gulley and culvert in the carriageway adjacent to the south-western corner of the property.

Area 4 - Field wall at Greywalls

- Option 2 – OCC to unblock gullies as required adjacent to south-west corner of property.

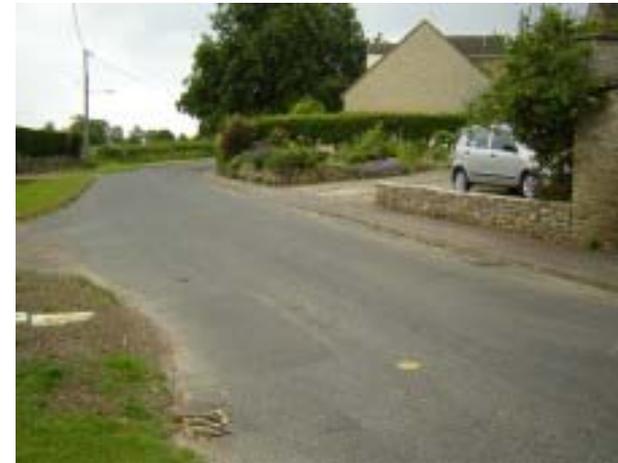
Area 4 - Junction at Green End
