WEST OXFORDSHIRE
DISTRICT COUNCIL

Parish Flood Report: **Brize Norton**

May 2008

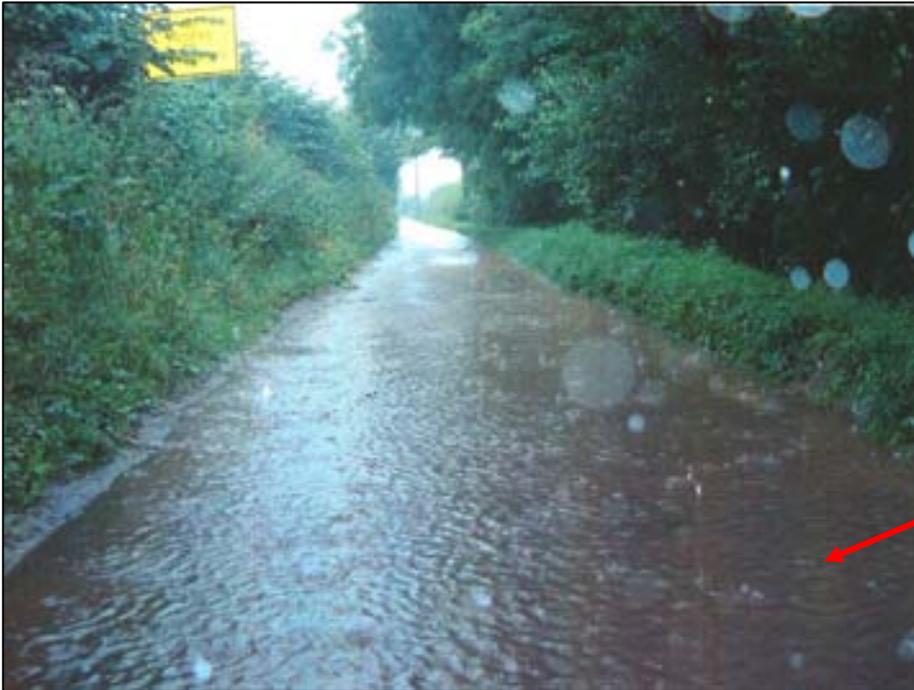
Photo 1 – Flood Waters on Kilkenny Lane

Drainage ditch

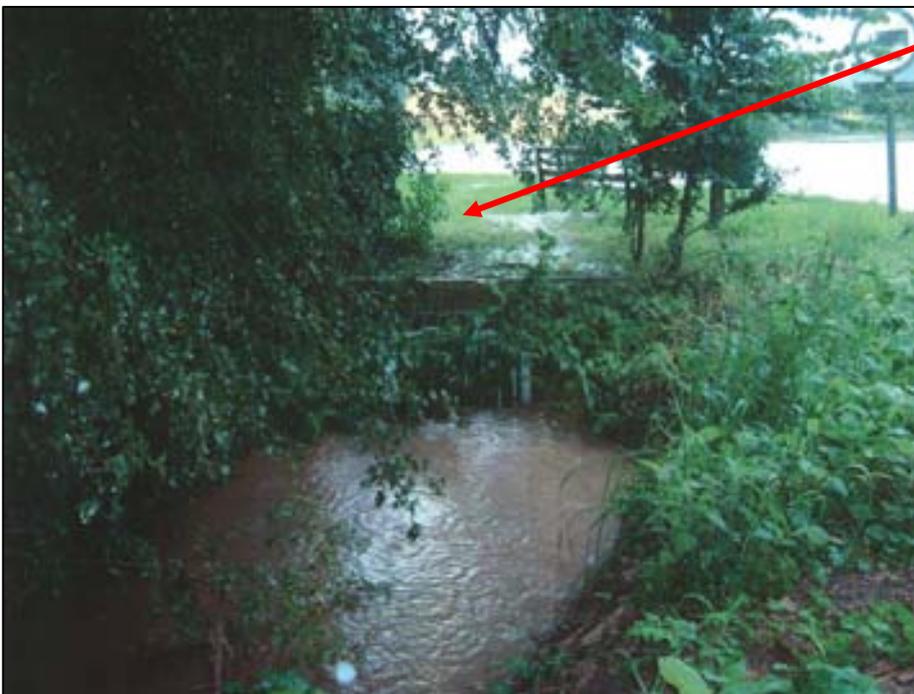
Photo 2 – 600mm diameter culvert at Kilkenny Lane/Burford Road

Currently the trash screen on the 600mm culvert at the end of Kilkenny Lane is cleared by local residents but debris regularly collects.

Culvert entrance

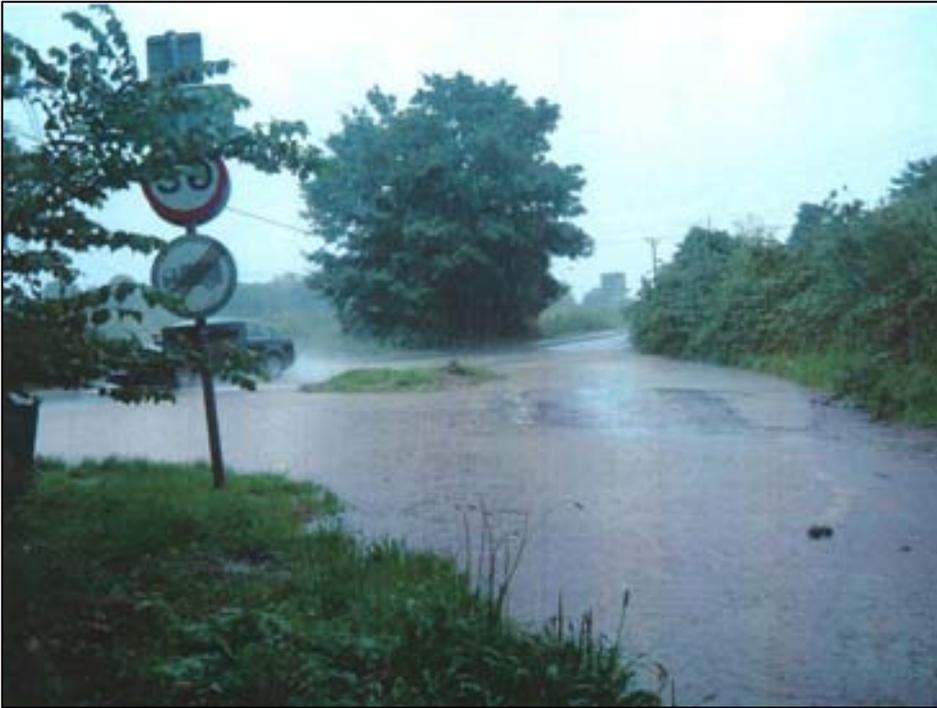
At the junction with the Burford Road (Photo 3) this ditch crosses under the road in a 600mm diameter pipe culvert which then exits in a 675mm diameter pipe culvert. This culvert feeds into a ditch and in turn into a second culvert system conveying flow under the new A40 link road before re-entering open flow in a ditch on the south side of the Burford Road flowing towards the Masons Arms and Grange Farm.

Photo 3 Kilkenny Lane at junction with Burford road in flood

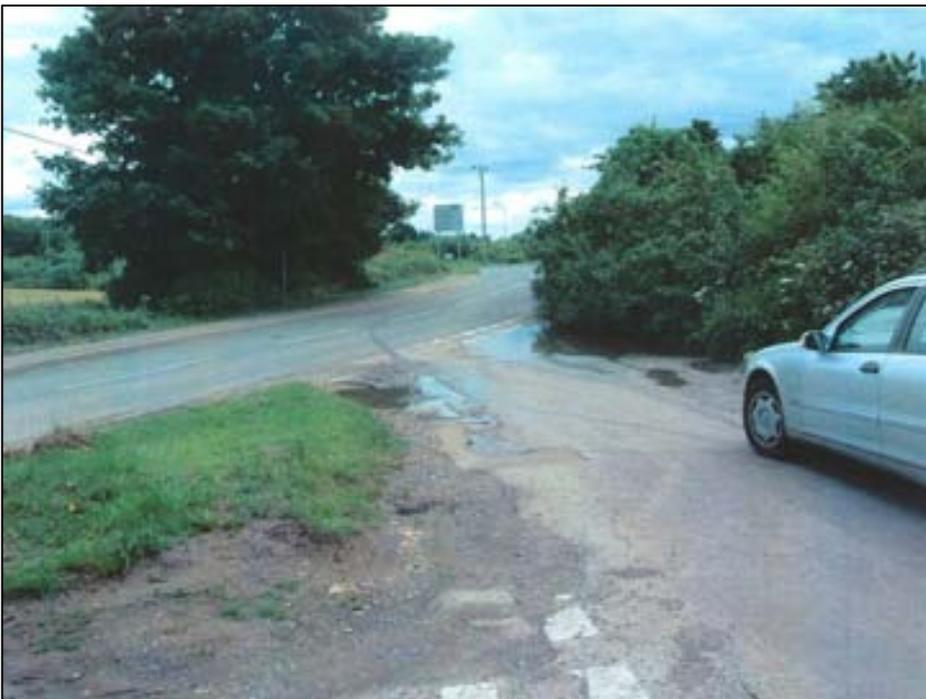
Photo 4 – Kilkenny Lane at junction with Burford Road, illustrating poor highway drainage

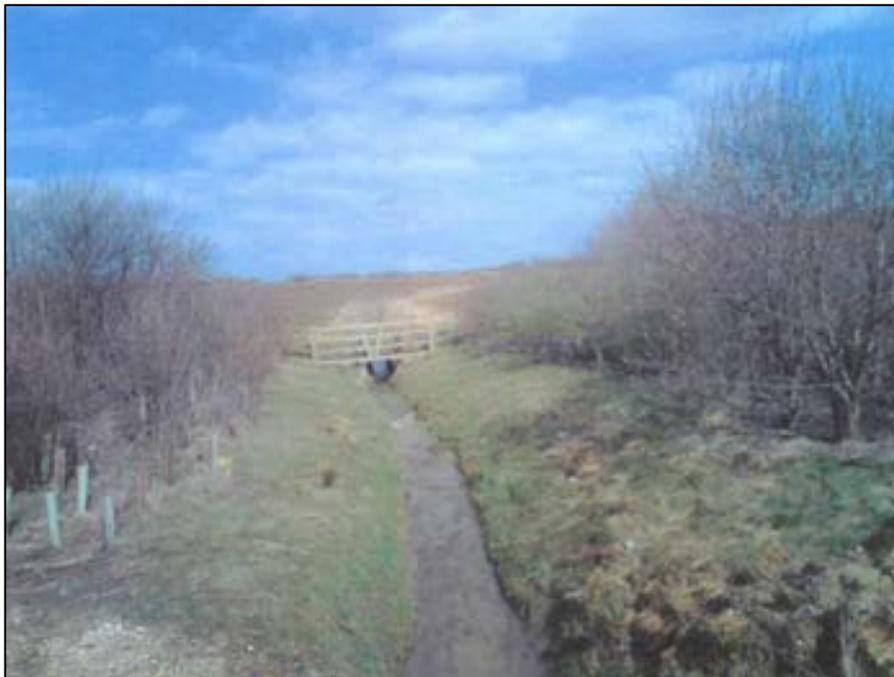
Photo 5, upstream catchment looking north from new A40 relief road

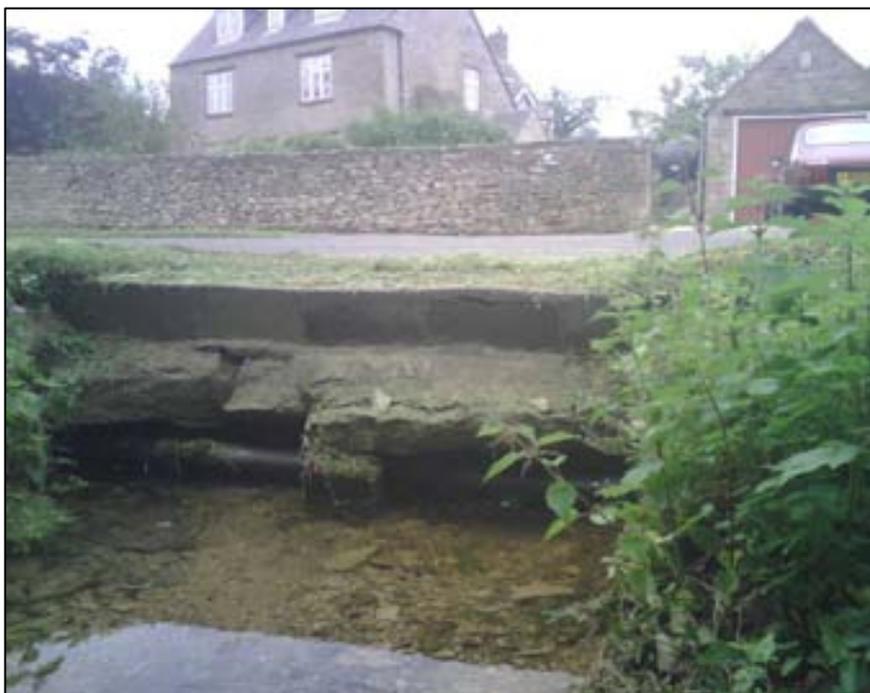
Photo 6, Burford Road at Masons Arms Pub

Water flowing from the upstream catchment, Photo 5, enters a culvert at the Masons Arms pub as illustrated in Photo 6.

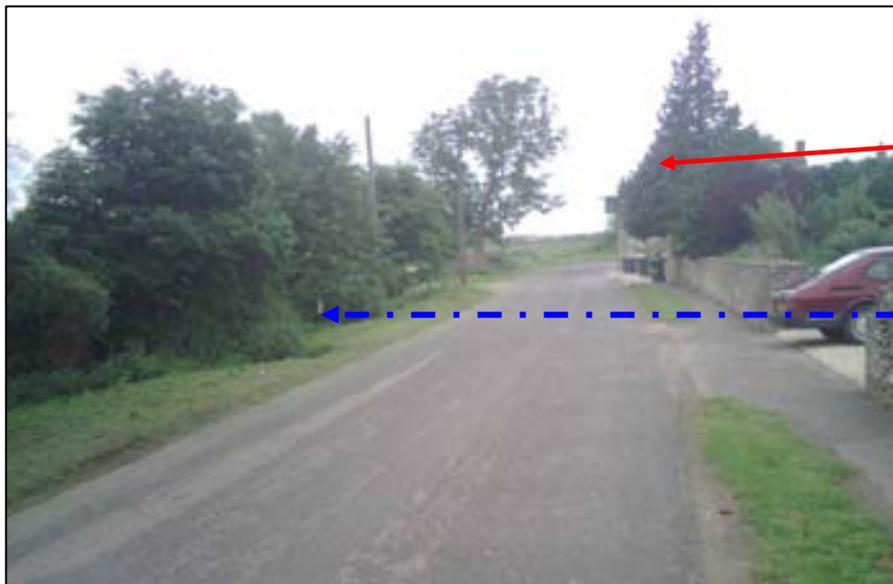
Photo 7 – Burford Road at Masons Arms

The blue dashed line shows the approximate location of the culvert carrying flows from the upstream catchment as shown in Photo 5 and 6 above

Masons Arms
pub

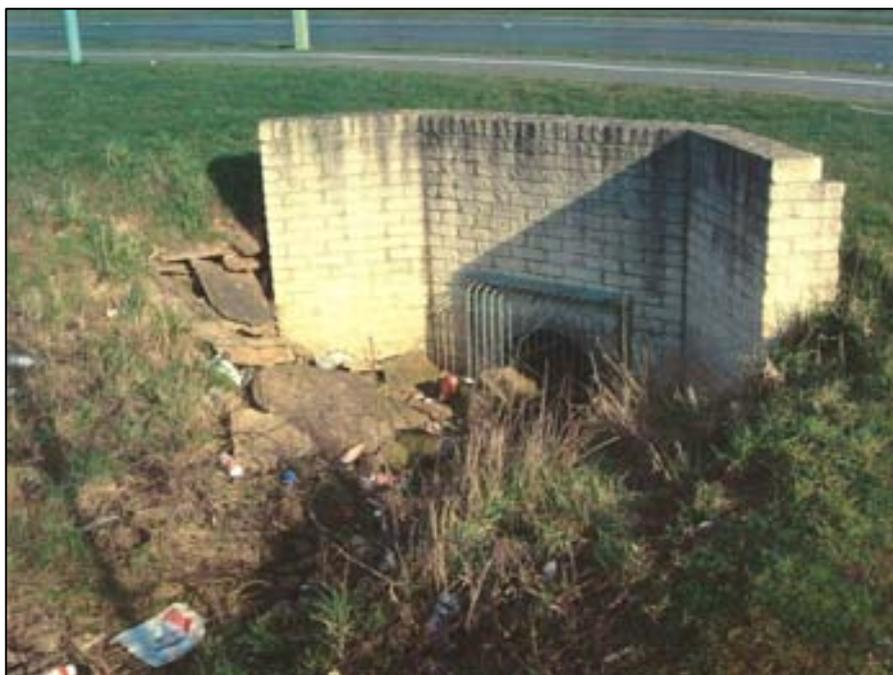
Photo 8 - Carterton Road to RAF Brize Norton (Area 3)

Culvert crosses road and links to drainage ditch running parallel to the attenuation pond. The shows litter and debris that builds up quickly in ditches flowing from Carterton. WODC propose that this drainage ditch links to the attenuation pond if TW release ownership to WODC

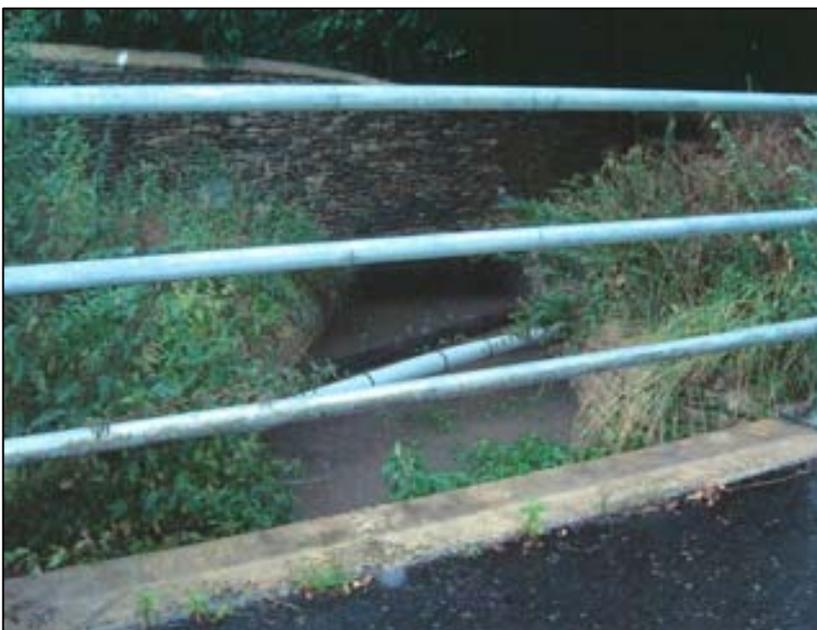
Photo 14 - New culvert crossing into private land south of Carterton Road

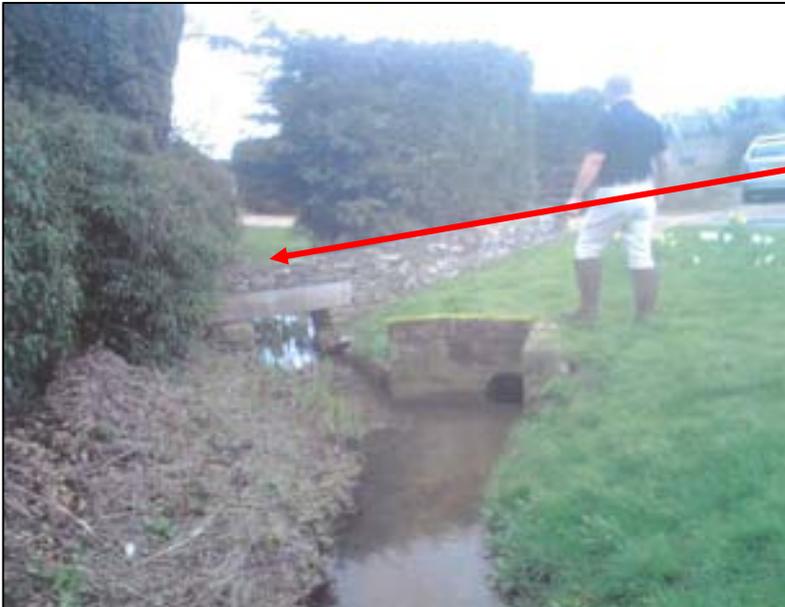
There are a large number of crossings of various size across the Highmoor Brook. These cause surcharging and flooding of surrounding property.

Photo 15 - Highmoor Brook at end of properties on Station Road. The channel is shown to split with some flow branching left to follow the Highmoor Brook and some carrying forward to join the highway ditch on the left hand side of Station Road

Wall which currently restricts flood flow

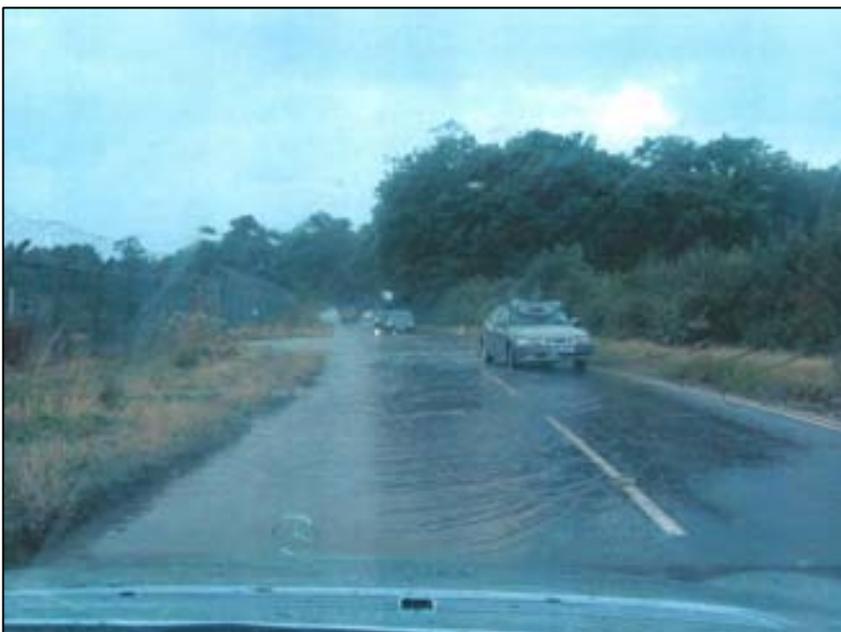
Photo 16 – Station Road at crossing on runway.
OCC have installed concrete lined grips at this location to improve road drainage
