WEST OXFORDSHIRE
DISTRICT COUNCIL

Parish Flood Report: **Shipton-Under-Wychwood**

May 2008

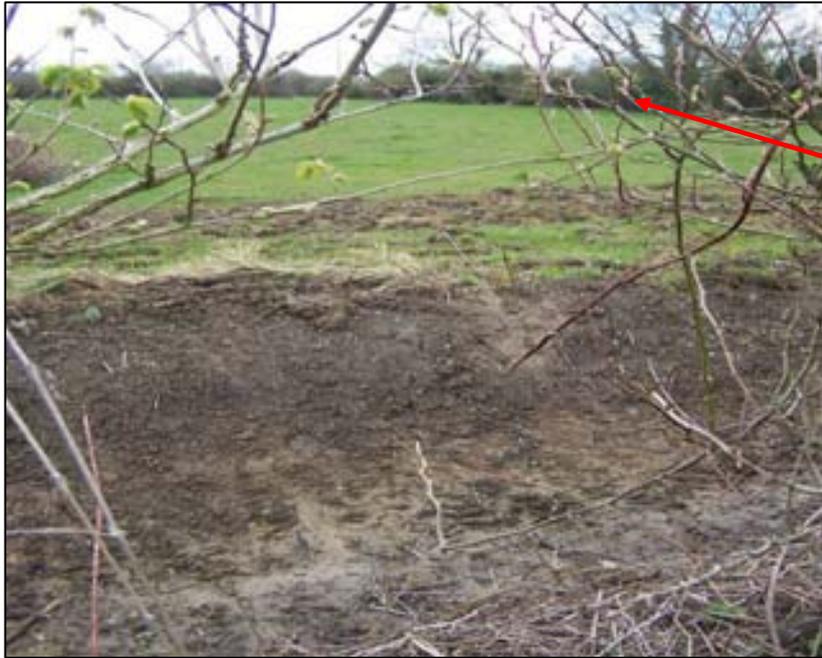
Little Stock
Brook

Cleared ditch behind Little Brook Meadow looking towards Little Stock Brook. Water flowed across this farm land and into properties due to a fallen tree blocking the Little Stock Brook.

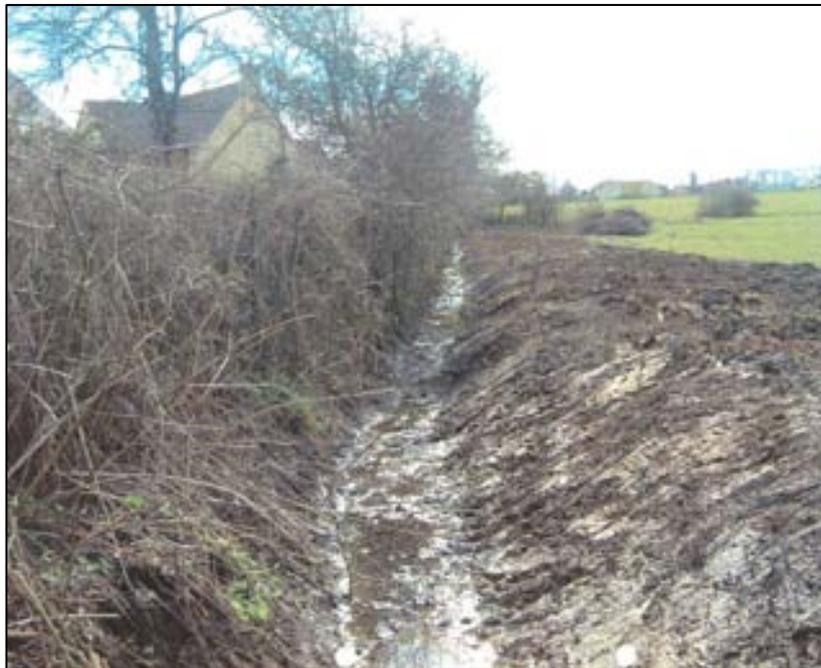
Cleared ditch behind Little Brook Meadow

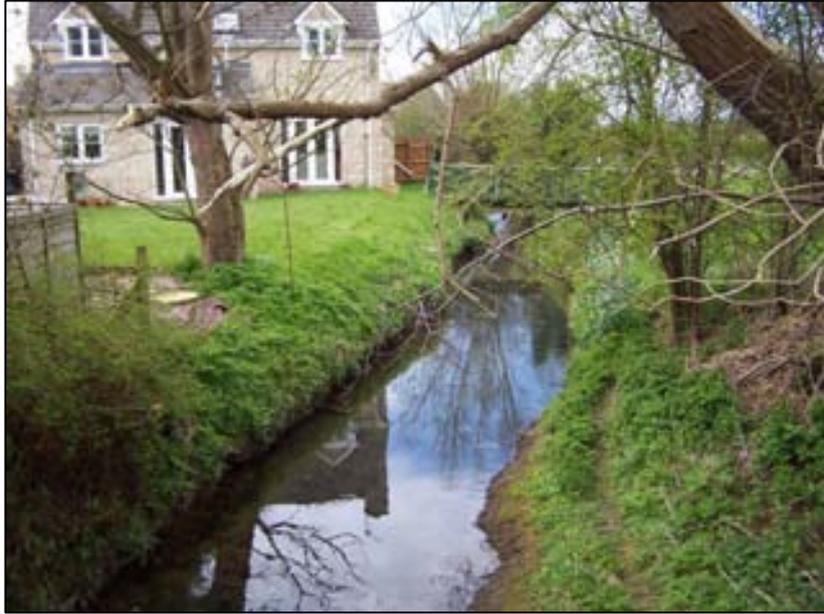
Properties at Little Brook Meadow adjacent to Little Stock Brook looking upstream from Meadow Lane Bridge.

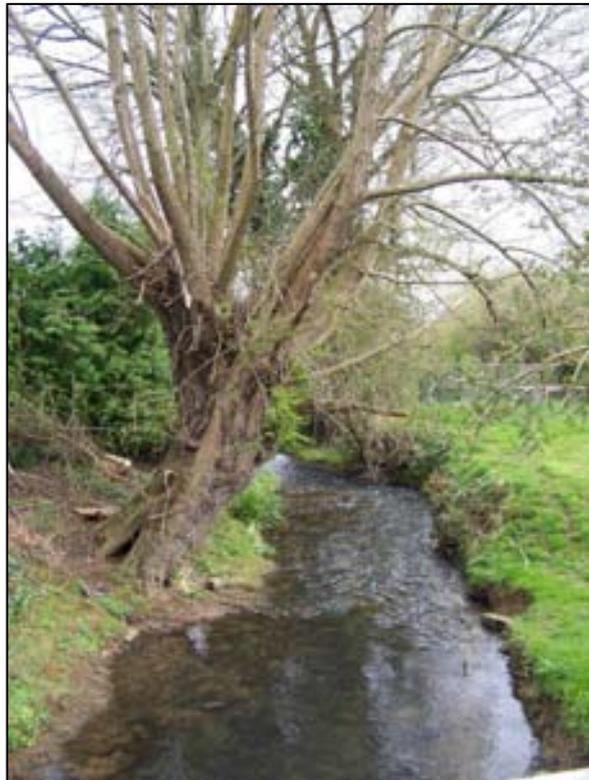
Photo taken from the Meadow Lane bridge illustrates lack of stream maintenance and coppicing of willows which may have led to the blockage of the Little Stock Brook a few hundred metres upstream.

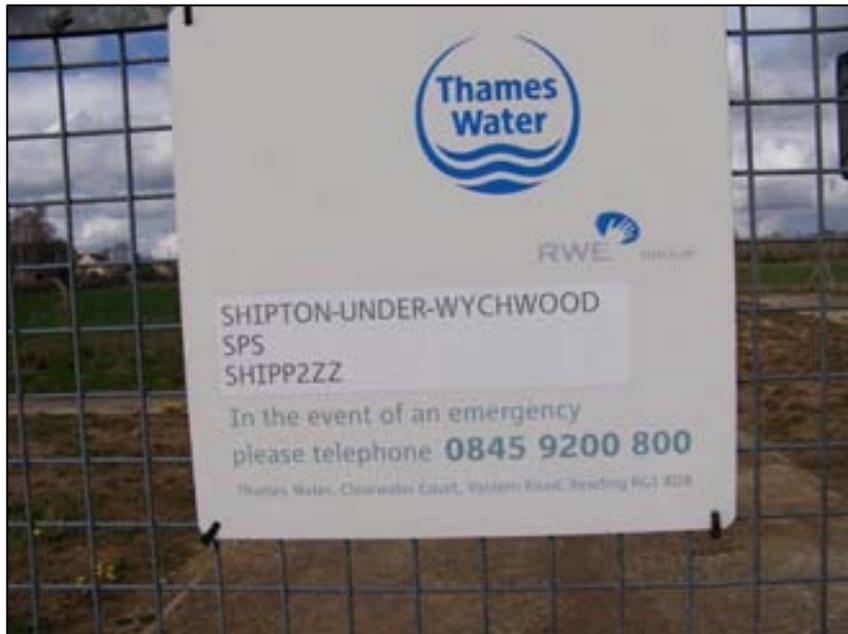
Thames Water Pumping Station

The Thames Water pumping station located opposite The Prebendal is unable to cope with large surface water volumes caused by surface water entering the foul sewer network during peak storm periods.

The pumping station is located on the northern side of Station road adjacent to the River Evenlode.

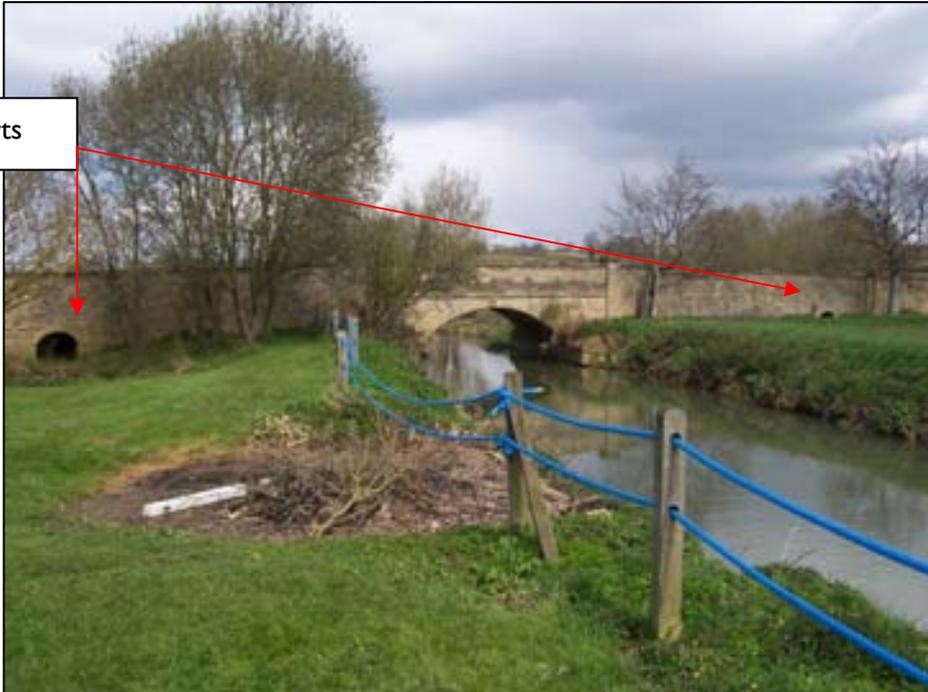
Flood relief culverts

River Evenlode looking upstream to Station Road Bridge. This photo shows the main channel and two flood relief culverts.

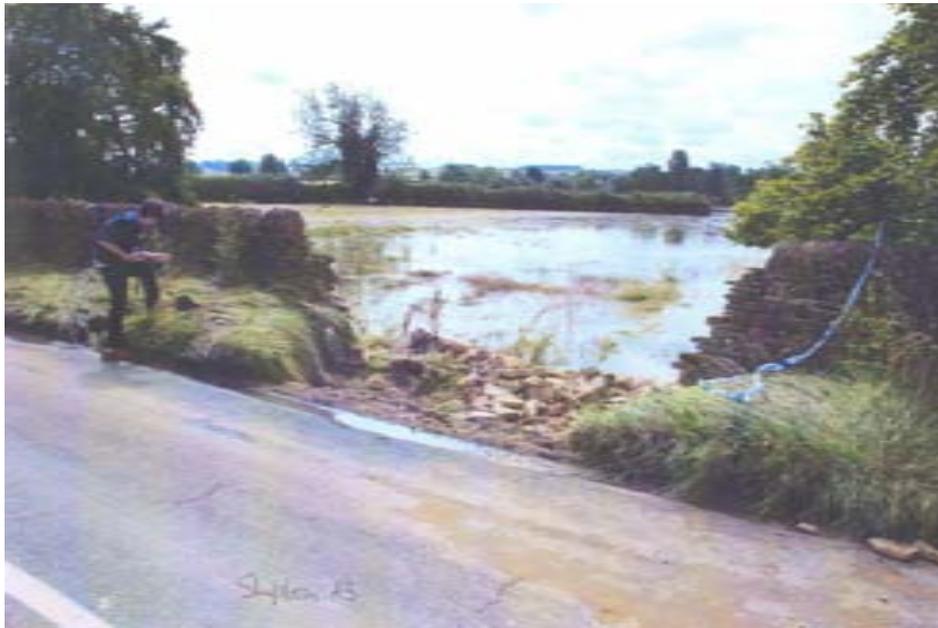
Damage to Station Road Bridge caused by flood waters from the River Evenlode

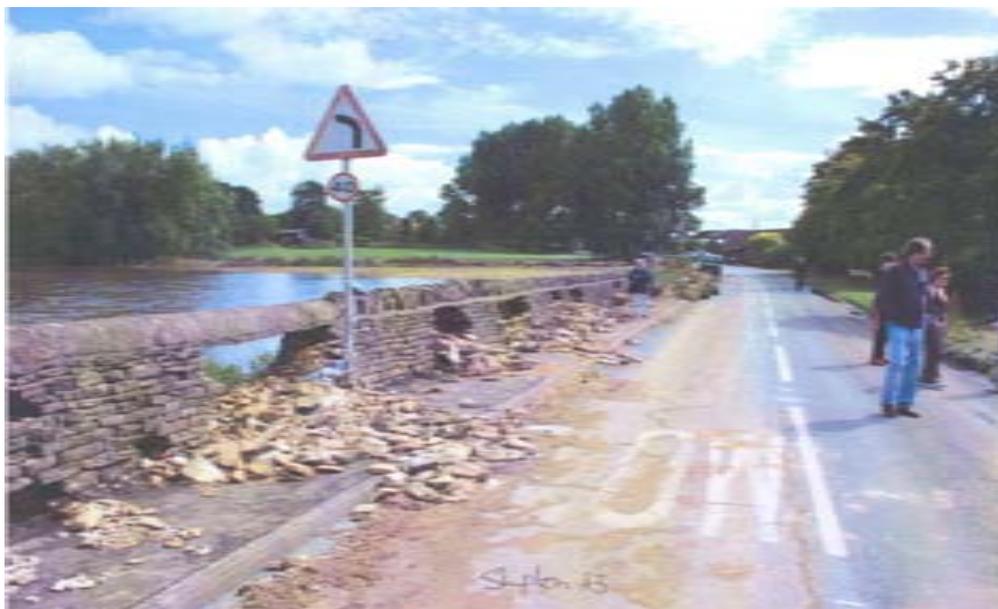
Damage caused to Station Road Bridge by floodwaters from the River Evenlode

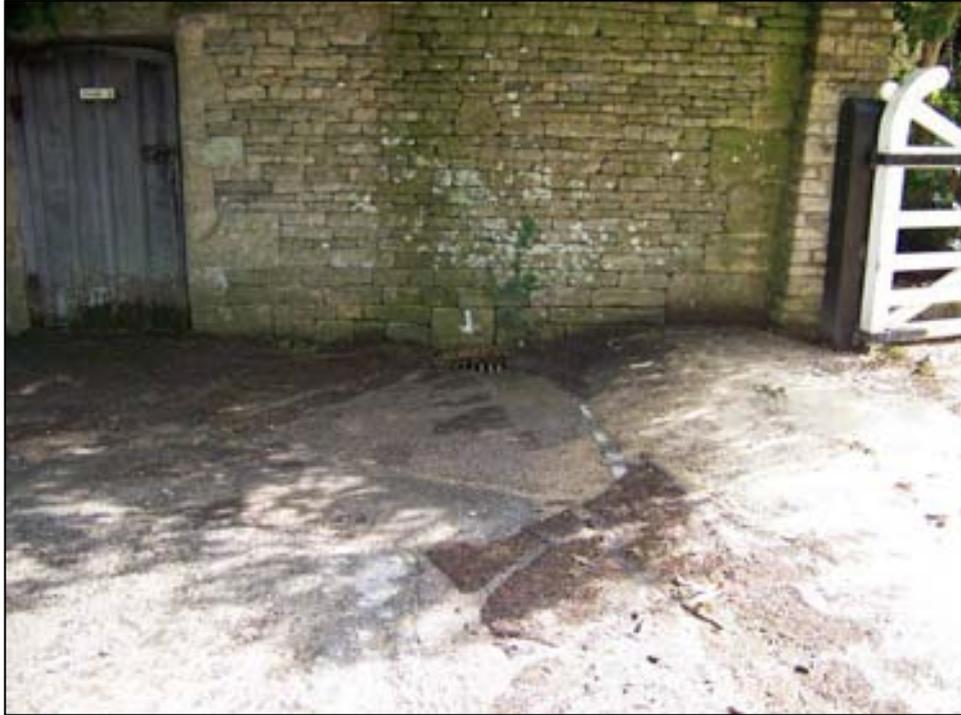
Flooding was caused by excess surface water running down Church Street due to a lack of surface water gullies. At the end of Church Street is a stone wall boundary of the Prebendal. Surface water collected at this point unable to drain down a gully in the road outside Kelbrook causing surface water to back up in the road and flow in through the driveway of properties.

Gully located at end of Church Street at Prebendal Wall. Outfall location to be defined.

B	Investigate outfall from gulley located at end of Church Street and clear it out if required.		OCC to investigate outfall and condition of drain located at the end of Church Street				Would prevent build up of surface water at bottom of Church Street as per July 2007		Up to £5,000	
Failure of sewage pump station caused backflow of sewage to flood properties										
C	Investigate foul/storm water misconnections connections			TW to investigate misconnections in area			Prevent overloading of Church Street foul sewer	none	£5,000 to £10,000	TW not currently planning any work at this location
D	Individual properties to fit anti-backflow valves on to foul drains					Kelbrook residents fitted non-return valve to private foul	Prevent sewage ingress to properties		Up to £5,000	
Area 4 – Blenheim Cottages										
	Surface run-off from fields on Shipton Down flows down Shipton Road and enters properties at dropped kerbs.

- Option A – OCC to improve surface water drainage along Church Street to include investigation of outfall and condition of drain located at the end of Church Street.
- Option B – OCC to investigate outfall from gully located at end of Church Street and jet if required.
- Option C - TW to investigate misconnections in foul network

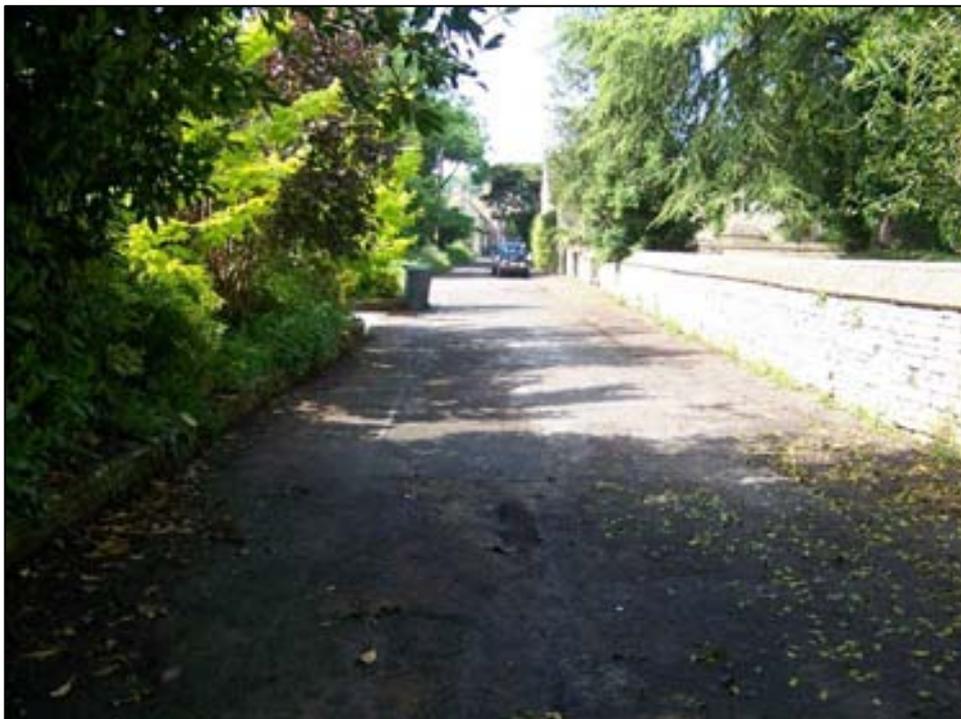
Looking away from Prebendal Wall back up Church Street

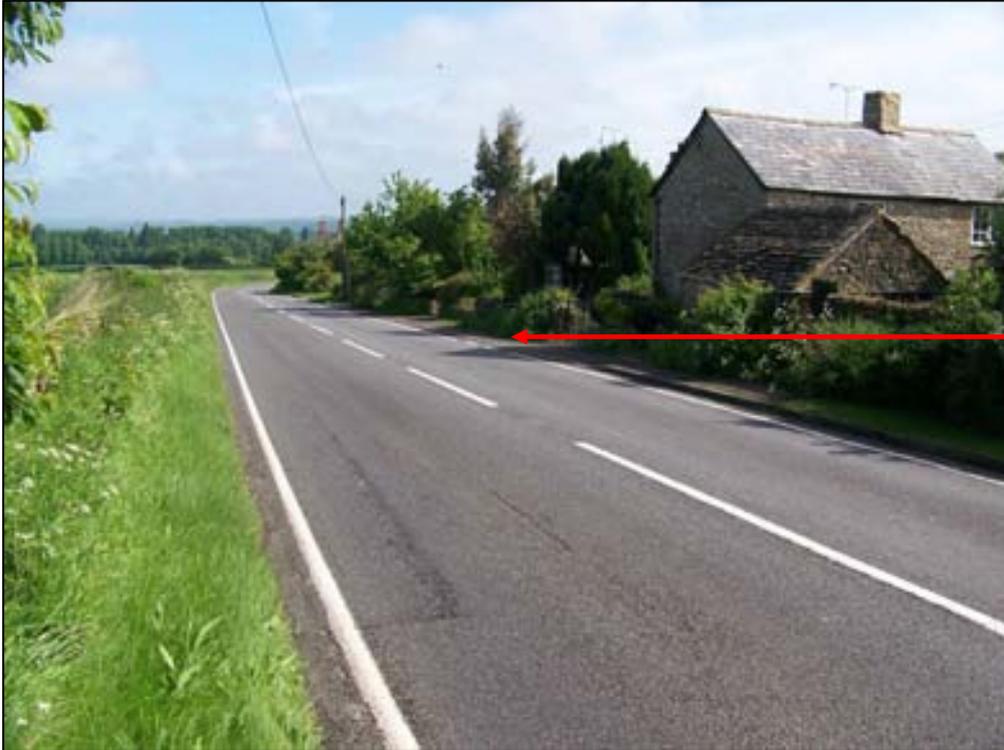
Dropped
kerbs to
be raised

A	Replace dropped kerbs with full kerbs – fit with concrete ramps		OCC highways department to investigate options						£5,000 to £20,000	OCC have budget to raise kerbs at Blenheim Cottages
B	Flood- resilient measures on properties.				WODC to provide a co-ordination role where required	Homeowners to provide protection against flooding to their properties e.g. flood boards, flood proofing of exterior walls, sand bags.	Only effective if flood boards are put in place before water levels rise.	None	Up to £5,000	Homeowners have not been approached regarding further resilience measures
