WEST OXFORDSHIRE  
DISTRICT COUNCIL

# Parish Flood Report: **Curbridge & Lew**

July 2008

Version 1 – This report may be revised in the future to incorporate ongoing consultation results

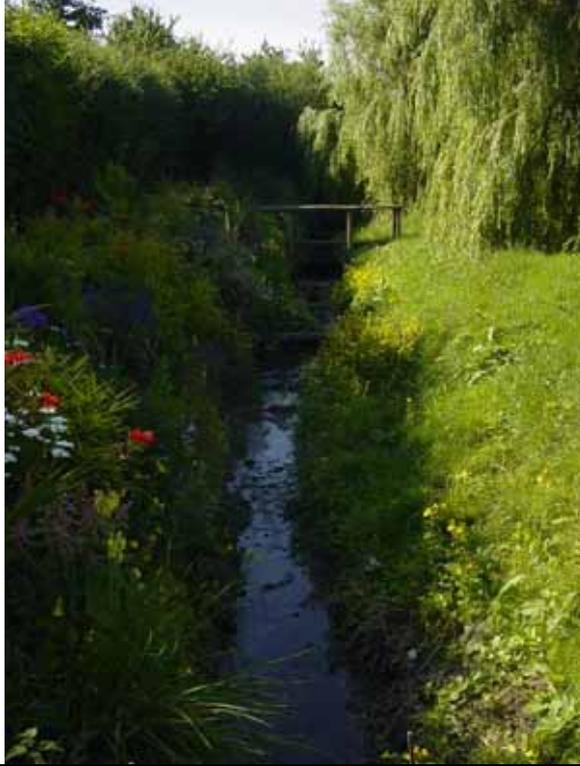
Elm Bank Ditch Viewed North West Upstream of Culvert Entrance, North of Main Road.

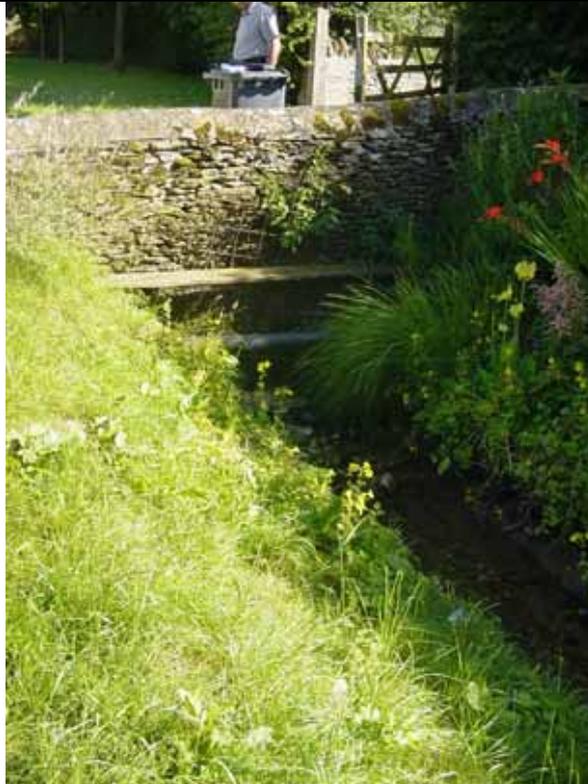
Upstream Entrance to 750mm Diameter Culvert North of Main Road.

The Elm Bank Ditch conveys water from its rural upstream catchment located to the north west of Curbridge into a 750mm pipe culvert located within private property at the north west corner of the village to the north of Main Road. This culvert conveys water in a general south easterly direction below Main Road and Well Lane to reappear in a private garden located to the east of Well Lane and south of Main Road as twin 600mm pipes.

- **Option C** - OCC Highways to undertake necessary repair and maintenance of existing drains, gullies and culverts, specifically the Elm Bank Ditch culvert below Main road and Well Lane. Cut grips and provide trash screens where necessary.  
This will increase the capacity of the culvert and prevent silt accumulation, restoring the effectiveness of the culvert to convey floodwater from the upper Elm Bank Ditch catchment, and will enable highway drains and gullies to work at their optimum design capacity, therefore not exacerbating the impact of overland flow originating from the agricultural land to the north west.

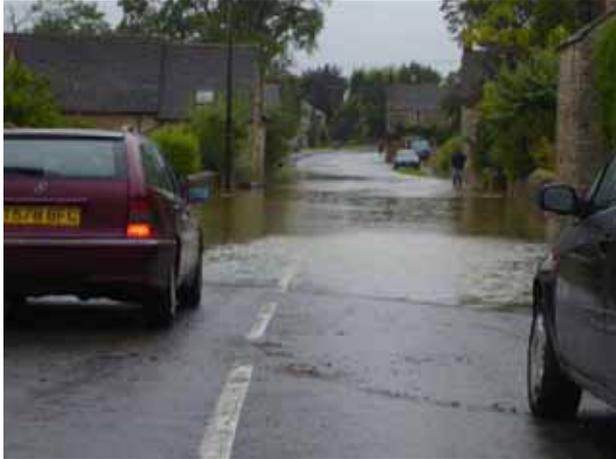
Flooding July 2007 - View West along Main Road, Curbridge.

During the 20<sup>th</sup> July 2007, excess water flowed overland passing through residential gardens before flooding the junction of Well Lane with Main Road. Properties were flooded as the overland flow attempted to return into the natural flow path of the Elm Bank Ditch. Residents were additionally concerned as sewage was present in the floodwater.

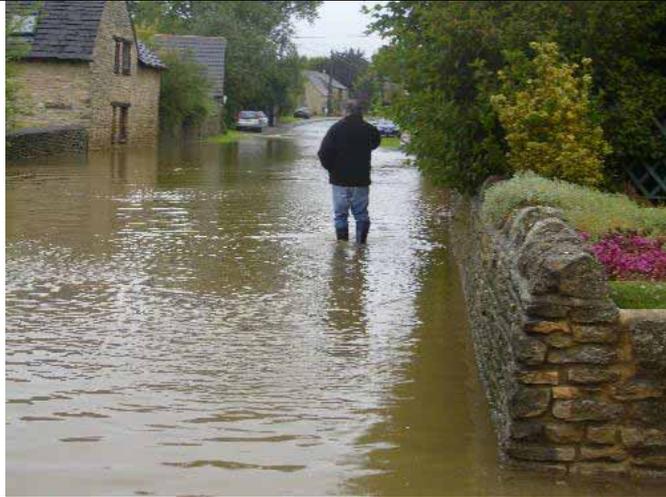
Flooding July 2007 - View West along Main Road, Curbridge

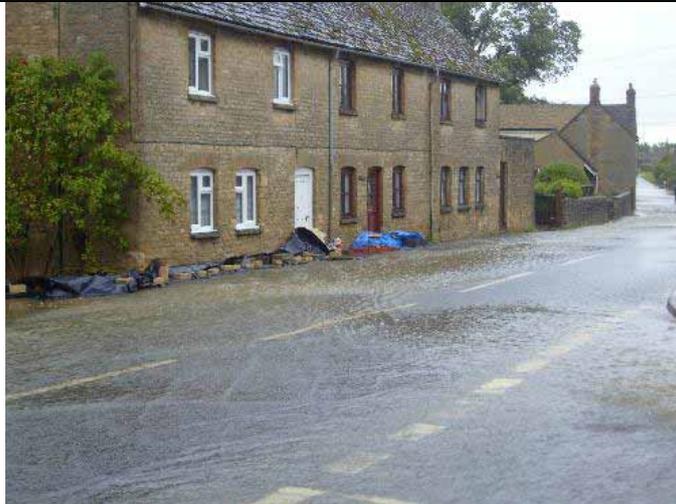
Flooding July 2007 - View East along Main Road, Curbridge

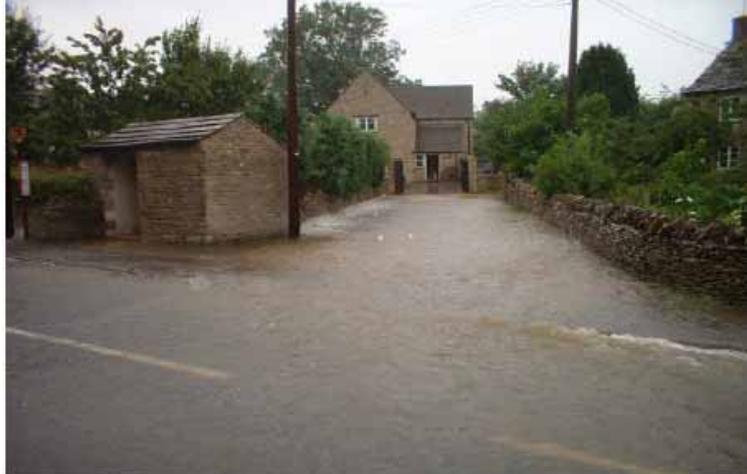
Flooding July 2007 - Property along Main Road.

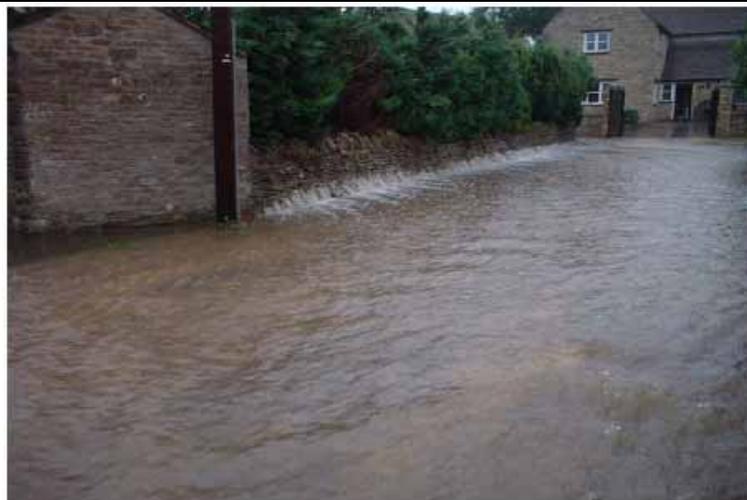
Flooding July 2007 - Property along Main Road.

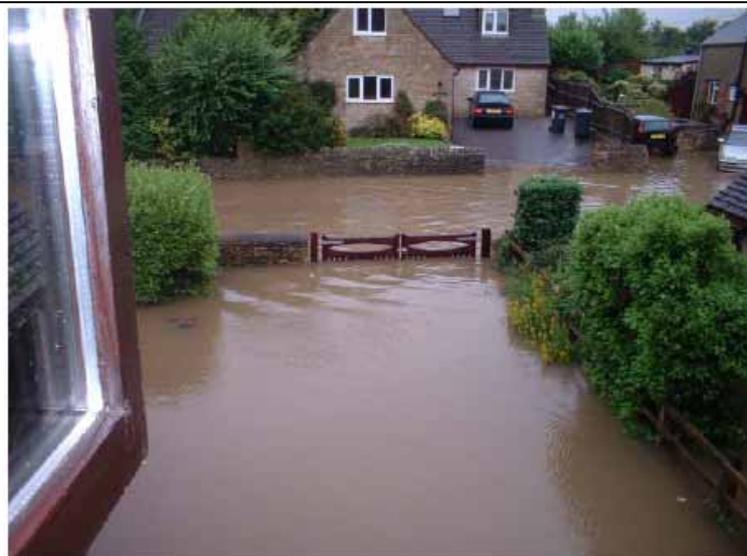
Flooding July 2007 - Property along Well Lane

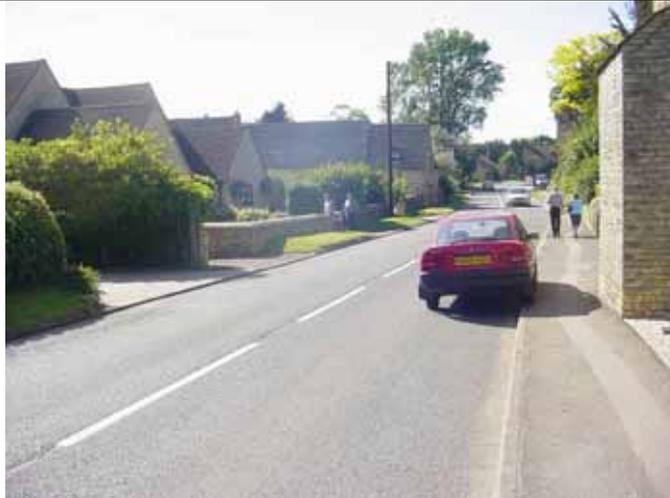
Previously Flooded Properties viewed North West along Main Road.

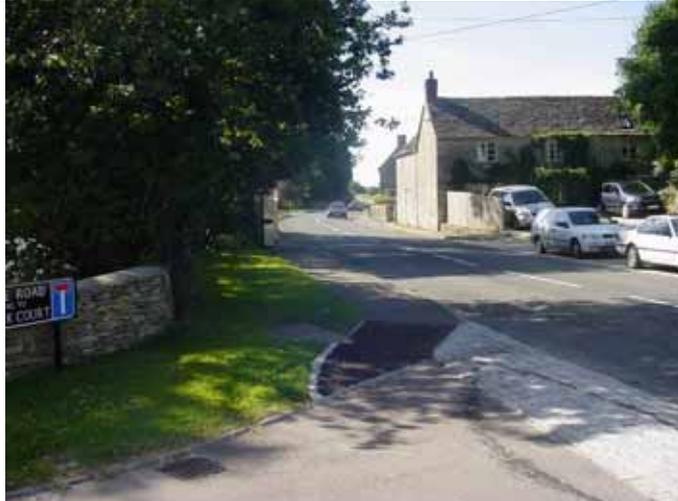
Previous Flow Route Viewed North West along Main Road towards the Junction with Well Lane.

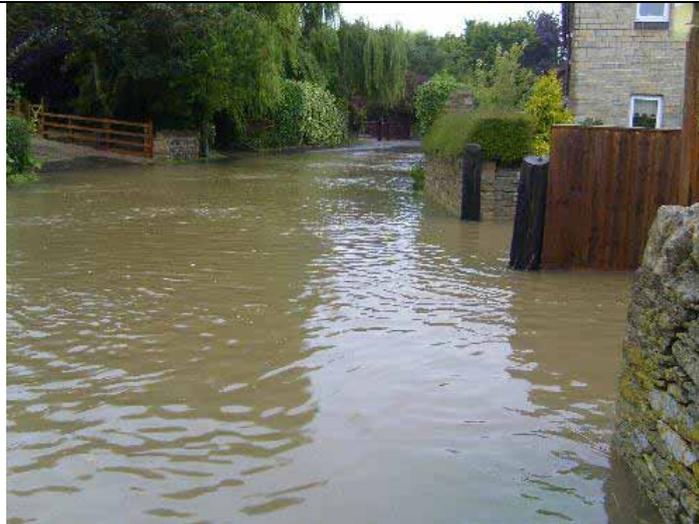
Flooding July 2007 - View North along Well Lane, Curbridge,

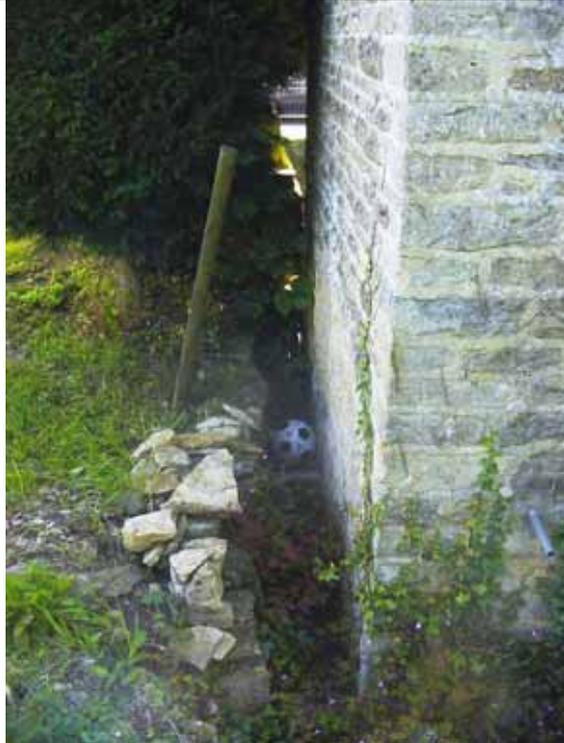
Floodwater experienced to the rear of the Curbridge Parish Hall during July 2007 was attributed to localised surface water runoff from agricultural fields at a higher elevation to the south of the A40 being unable to discharge, resulting in internal damage.

The Hall has a drainage ditch around the rear perimeter where it is believed that water collects as there is currently no mechanism for it to discharge, compounding the impact of the flood event. Flooding of this nature was further experienced on the 3<sup>rd</sup> June 2008.

Curbridge Parish Hall was flooded from surface water runoff from the north as a result of local topography and poorly drained perimeter ditch.

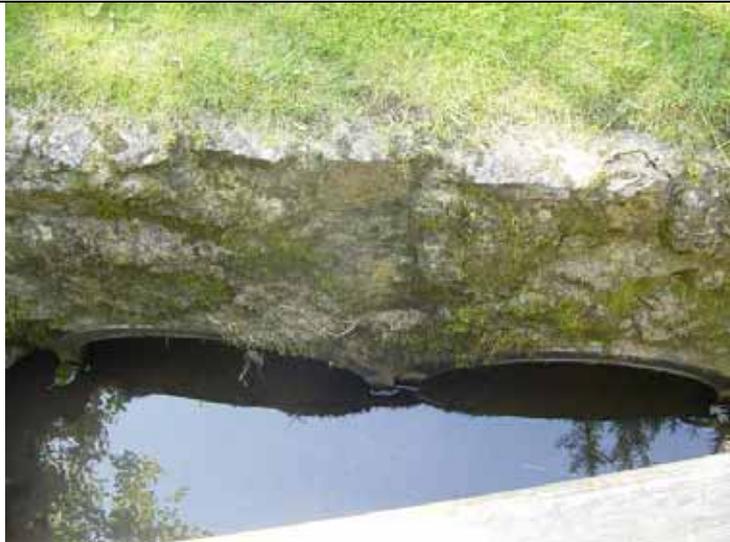
Downstream End of 2 x 600mm Diameter Pipe Culvert East of Well Lane and south of Main Road.

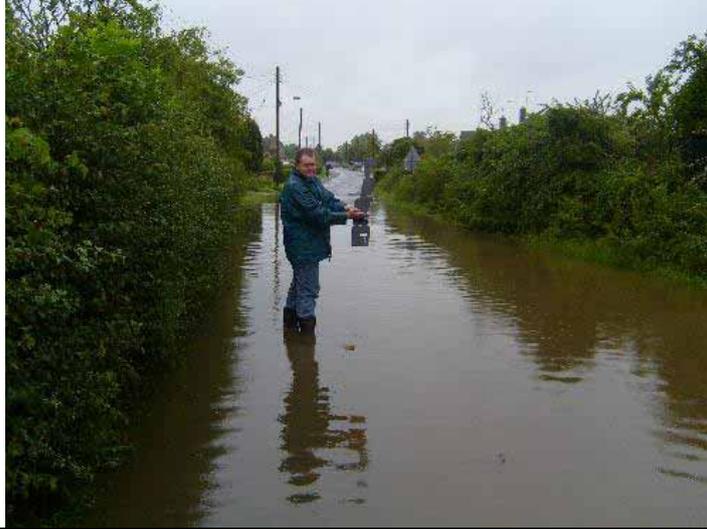
Flooding July 2007 - View South along Well Lane, Curbridge

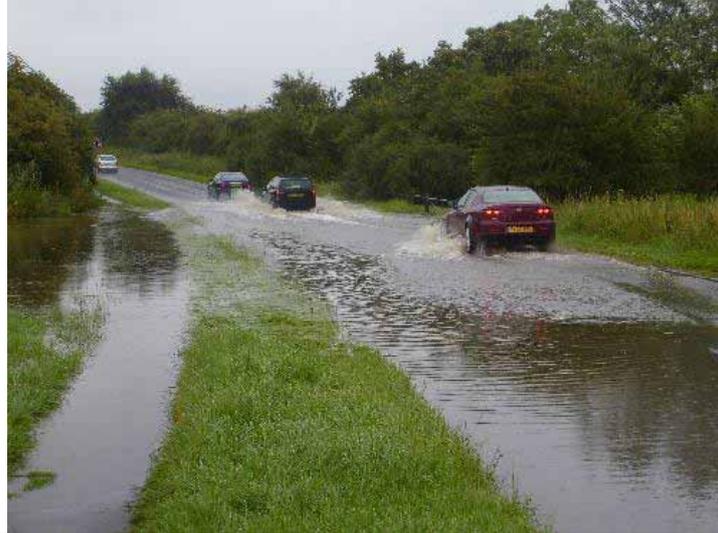
Floodwater experienced at the junctions of Well Lane and Main Road with Bampton Road in Curbridge during July 2007 was attributed to overland flow originating as surface water runoff from surrounding agricultural fields. Multiple houses along Bampton Road were also flooded and it was believed by residents that blocked gullies and highly vegetated highway drains and ditches alongside the road exacerbated the impact of the flood event.

Flooding July 2007 - Flooding on Bampton Road (A4095), Curbridge where Elm Bank Ditch flows beneath Bampton Road.
